This home is not sweat equity fun project or a “lipstick on a pig flip.”

The home has serious issues/repairs that need a seasoned contractor with a knowledgeable team to figure out assessing and fixing to have the ability to grow equity and maximize its potential and profit.

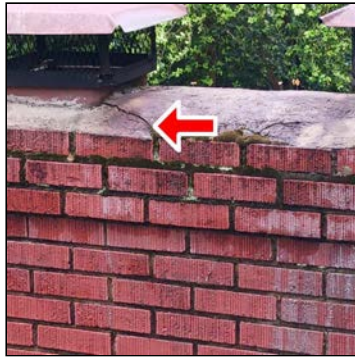
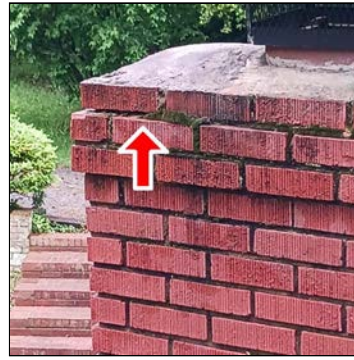
Observed cracked areas of the chimney mortar cap and open areas between cap and flue liner. Condition is conducive to water penetrations at interior of chimney / fireplace. Seal with proper material to avoid water penetrations. Evaluation / Correction by a qualified chimney contractor is recommended for this entire condition.

Chimney cracks

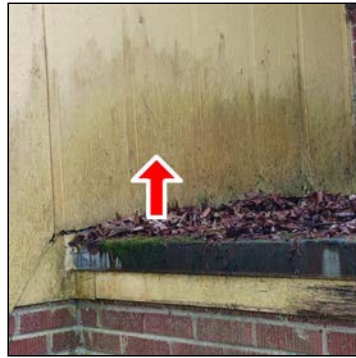
Rear

Observed damage and deterioration at multiple areas of the siding and wood trim, see photos for

locations. We also observed multiple areas where the siding is gaped around windows, doors, and other trim components. Areas that were observed are from ground level (only) but there may be additional repairs needed higher up and / or out of view. Recommend wood repair / replacement / caulking / painting to protect from the elements and prevent water penetrations / other damages. Evaluation / Correction by a qualified siding contractor is recommended for the entire wood exterior condition.

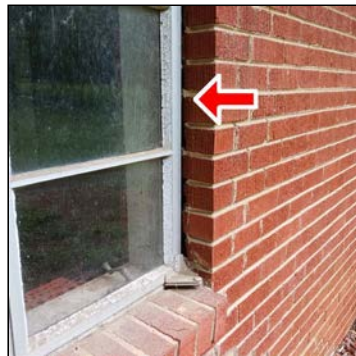
Observed multiple areas of separation at the front left breezeway window and the brick veneer. This may be caused by a settling condition or brick pulling away in this area. Condition is conducive to further damages and potential water penetrations. Evaluation / Correction by a qualified general contractor is recommended for this entire condition.

Front left window gap

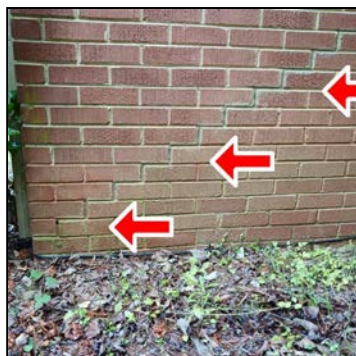
Front left

Observed a stair step crack in the brick veneer at multiple locations around the home with some displacement evident (See photos for locations). Condition is conducive to further damages. Evaluation / Correction by a qualified general / masonry contractor is recommended for this entire condition.

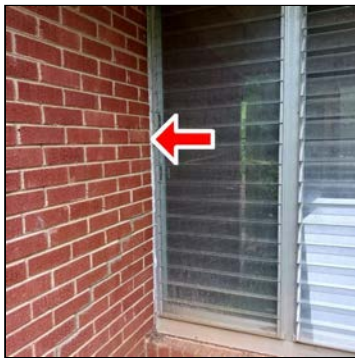
Front left

Observed multiple locations where caulk sealing is needed where the brick veneer meets the vinyl / wood / metal trim (See photos for locations). Condition is conducive to potential water penetrations and other damage. Evaluation / Correction by a qualified handyman contractor is recommended for this entire condition.

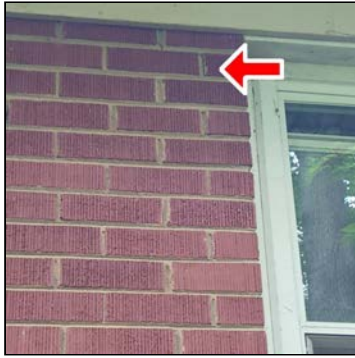
Right side

Observed small cracks in the brick veneer at several locations (See photos for locations). These are typical in nature due to age and normal masonry shrinkage. Although small cracks in brick veneers

are typical, these areas should be resealed too prevent any water penetrations or damages and subsequently monitored. Evaluation / Correction by a qualified handyman contractor is recommended for this entire condition.

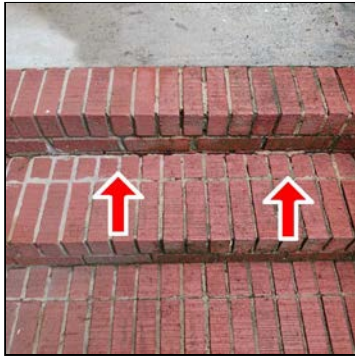
Front steps

Observed open mortar joints and loose bricks at the front steps in several locations. All open mortar joints need to be sealed to prevent water penetrations. Condition is conducive to further damages. Evaluation / Correction by a qualified handyman contractor is recommended for this entire condition.

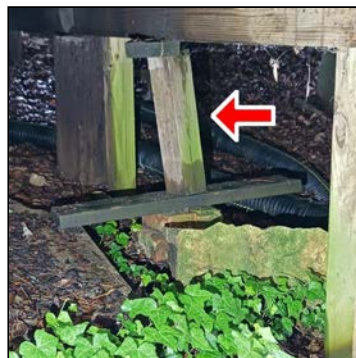
Observed improperly supported columns underneath the rear deck. These columns are leaning and lacking proper footings underneath them which can lead to structural movement. Evaluation / Correction by a qualified general contractor is recommended for this entire condition.

Missing column footings

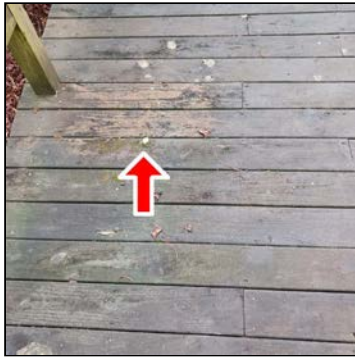
Rear deck

Observed decking and railings to have cracked / deteriorated materials in various areas and some nails are backing out. Repair / replace cracked and deteriorated materials as needed and for weathered deck surfaces we recommend sealing wood as needed and resetting nails. Condition is conducive to further damages. Evaluation / Correction by a qualified general / handyman contractor is recommended for this entire deck / condition.

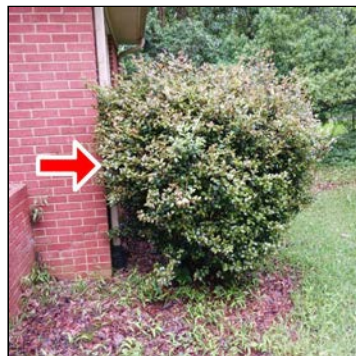
Observed vegetation that is in direct contact with building materials. This is a condition conducive to further damages. Cutting back at least 12 inches is recommended. Evaluation / Correction by a qualified handyman contractor is recommended for this entire condition.

Vegetation

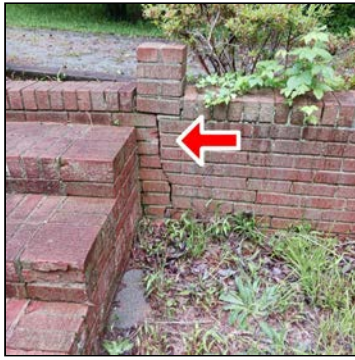
Front retaining wall

Observed multiple retaining walls that are leaning and have areas of displacement in the brick.

Condition is conducive to further retaining wall failures over time. Evaluation / Correction by a qualified general contractor is recommended for this entire condition.

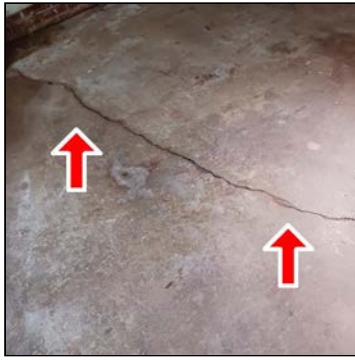
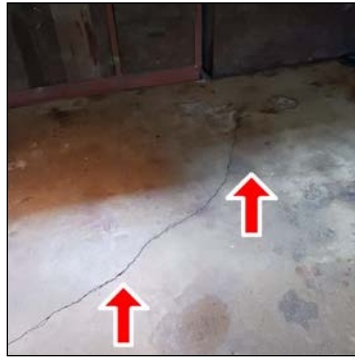
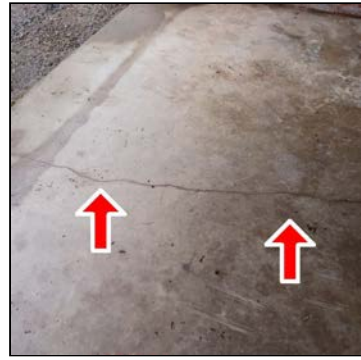
Observed sections of the garage floor that are raised up with some displacement. Although concrete movement and typical cracking is common in almost every home this condition poses a safety (tripping) hazard. Evaluation / Correction by a qualified general / concrete contractor is recommended for this entire condition.

Garage slab cracks

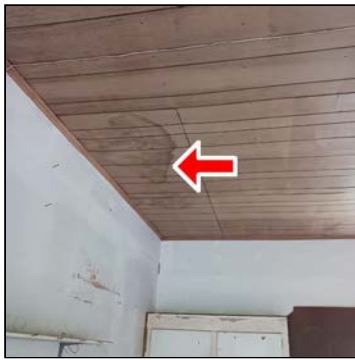
Garage ceiling

Observed water stains and damaged areas in the garage ceiling and walls in multiple locations. These stains are likely from previous roof leaks and damages. Evaluation / Correction by a qualified general contractor is recommended for this entire condition.

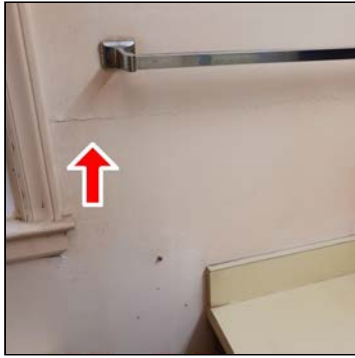
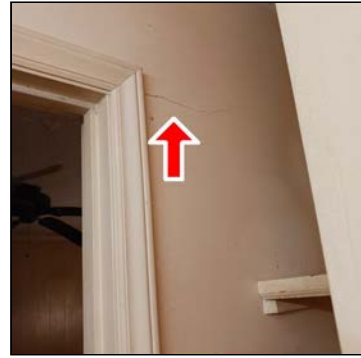
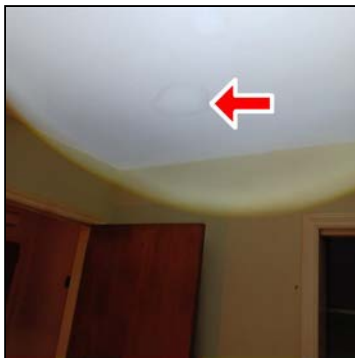
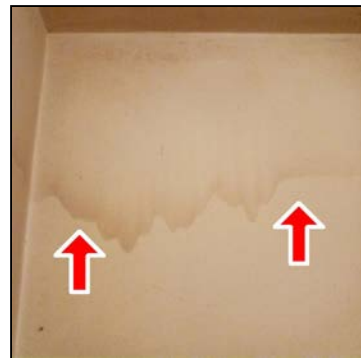
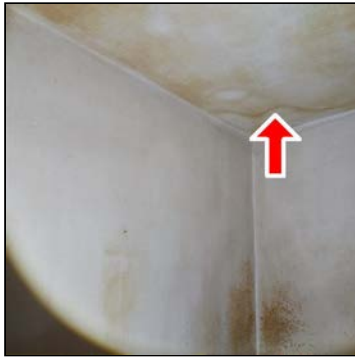
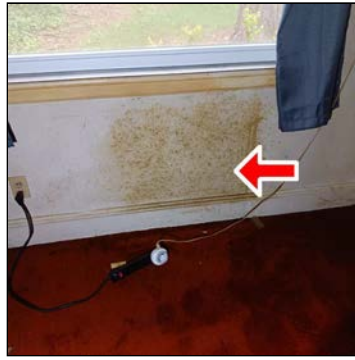
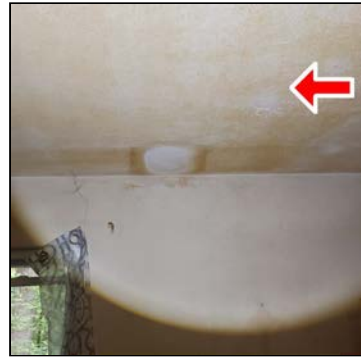
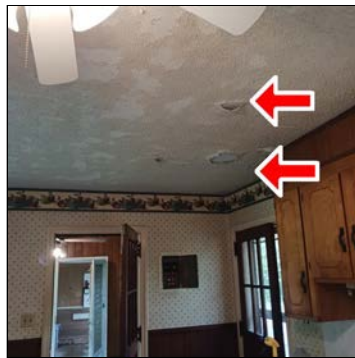
Observed extensive drywall cracks, water stains, damaged ceilings and smoke damages throughout the home. Condition is conducive to further damages. Evaluation / Correction by a qualified general contractor is recommended for this entire condition.

Damages throughout

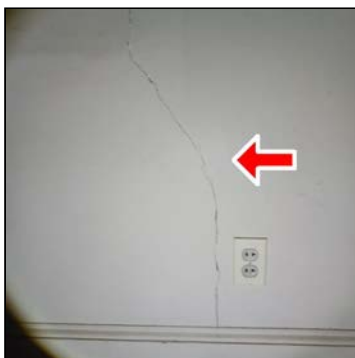
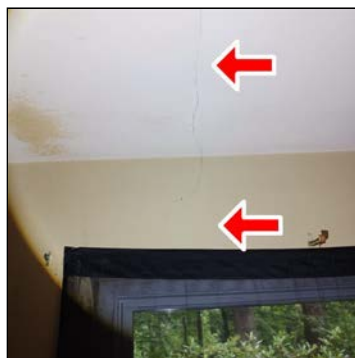
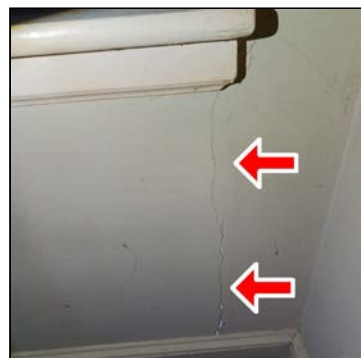
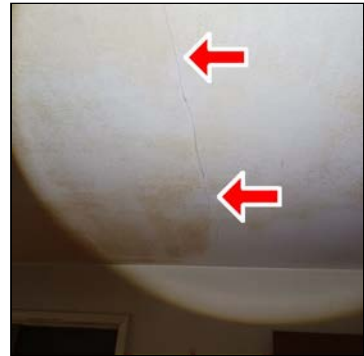
Observed multiple drywall cracks with some displacement throughout the home. Some of these cracks appear to be structural in nature and need further review. Evaluation / Correction by a qualified general contractor / structural engineer is recommended for this entire condition.

Displaced drywall cracks throughout

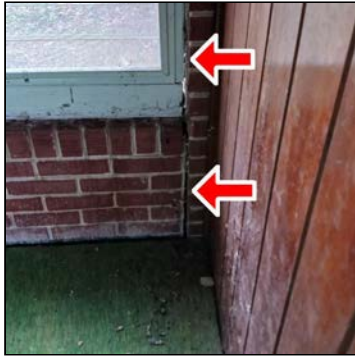
Observed gaps in the brickwork with visible daylight in the walkway between the garage and the house. Condition is conducive to further damages / water penetrations. Evaluation / Correction by a qualified general contractor is recommended for this entire condition.

Visible daylight in garage walkway walls

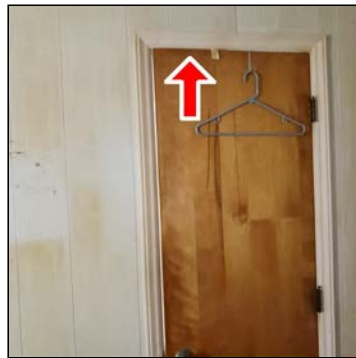
Master bathroom

Observed that several of the room and closet doors hit and rub the door frames, see photos for locations. This is typically due to expansion and contraction from seasonal interior humidity. (Recommend checking all in all locations) Evaluation / Correction by a qualified handyman contractor is recommended for this entire condition.

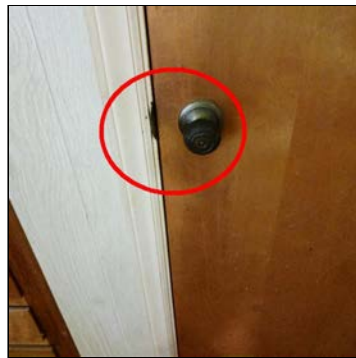
Master closet

Observed that several of the room and closet doors have malfunctioning hardware that will not latch correctly, see photos for locations. This is typically due to expansion and contraction from seasonal interior humidity. (Recommend checking all in all locations) Evaluation / Correction by a qualified handyman contractor is recommended for this entire condition.

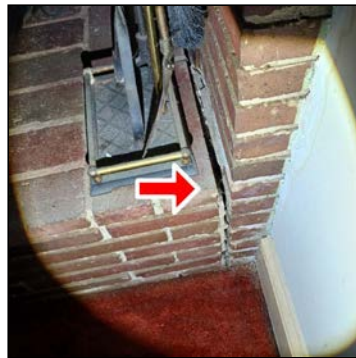
Observed a large gap between the fireplace hearth and the chimney. This may be an indication that the chimney has moved and separated itself from the home. Condition is conducive to further damages. Evaluation / Correction by a qualified general contractor is recommended for this entire condition.

Large gaps at base of fireplace

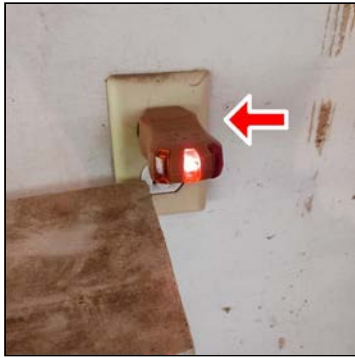
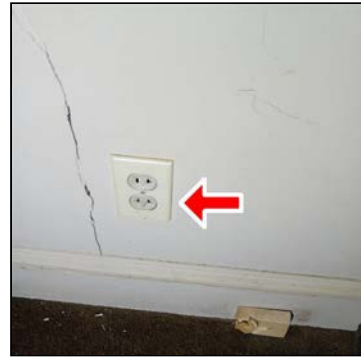
Observed electrical outlets in multiple areas that tested to have an either no / open or broken ground throughout the home. Condition is conducive to potential safety hazards. Evaluation / Correction by a qualified electrical contractor is recommended for this entire condition.

Ungrounded outlets throughout

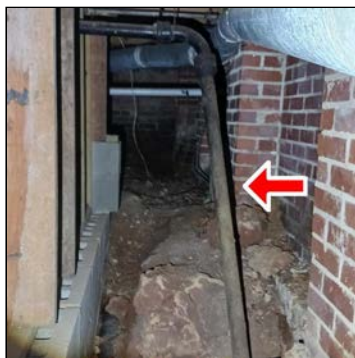
Observed that portions of the plumbing drain system are cast iron piping. Although no visible leaks were found at the time of inspection, cast iron piping can corrode in areas that are not visible. Also the rubber band boots that are used for connections are prone to leaking. Evaluation / Correction by a qualified plumbing contractor is recommended for this entire condition.

Cast iron pipes

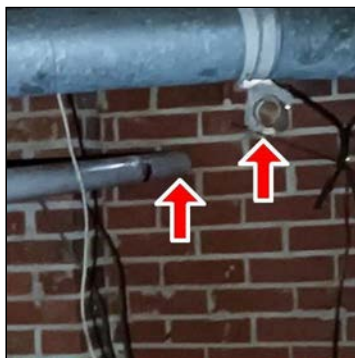
Observed that the furnace flue / exhaust pipe has come disconnected inside the crawl space. This means that the exhaust and carbon monoxide fumes are not exiting the crawl space to the exterior. **THIS IS A SAFETY HAZARD.** Evaluation / Correction by a qualified HVAC contractor is recommended for this entire condition.

Furnace flue vent disconnected in crawl

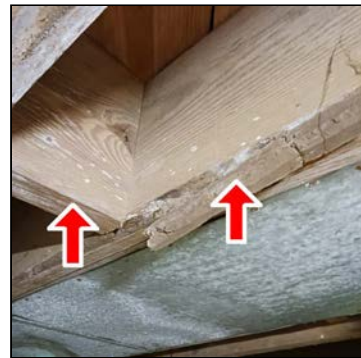
Fungi

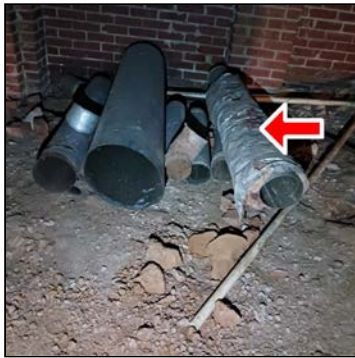
Observed wood debris and other trash items in the crawl space. All wood, trash or cardboard debris must be kept out of crawl space areas. Condition is conducive to wood destroying insects and other potential concerns. Evaluation / Correction by a qualified handyman contractor is recommended for this entire condition.

Trash in crawl space

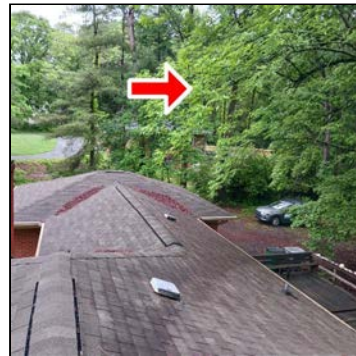
1.0 Observed several tree limbs that are in contact with roof or hanging near roof that should be trimmed back (See photos for locations). This is a condition conducive to advanced roof wear and possible damages to other building materials. Evaluation / Correction by a qualified handyman contractor is recommended for this entire condition.

Overhanging branches

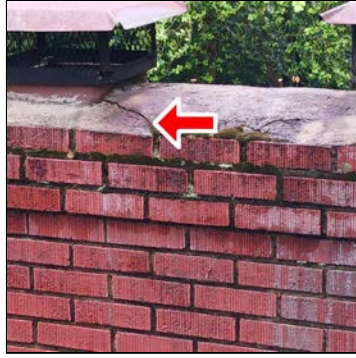
material to avoid water penetrations. Evaluation / Correction by a qualified chimney contractor is recommended for this entire condition.

Chimney cracks

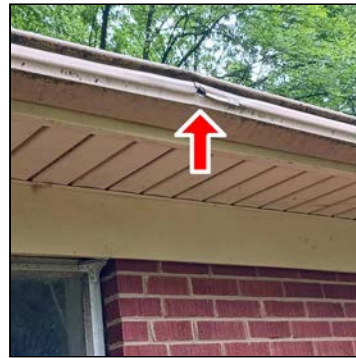
Front left

1.5 Observed a section of gutter at the front left side that has been damaged and needs to be repaired. Condition is conducive to further damages. Evaluation / Correction by a qualified gutter contractor is recommended for this entire condition.

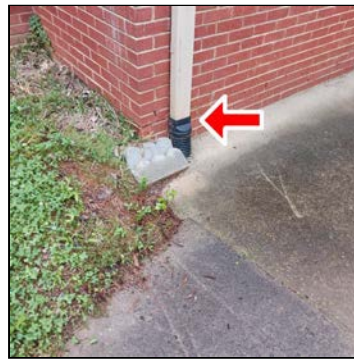
Underground downspouts

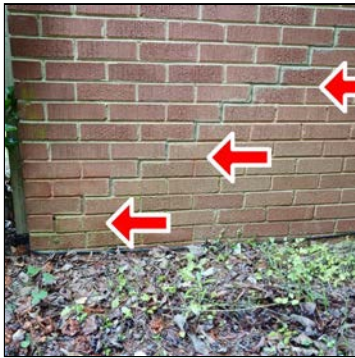
Front left

2.4 Observed a stair step crack in the brick veneer at multiple locations around the home with some displacement evident (See photos for locations). Condition is conducive to further damages. Evaluation / Correction by a qualified general / masonry contractor is recommended for this entire condition.

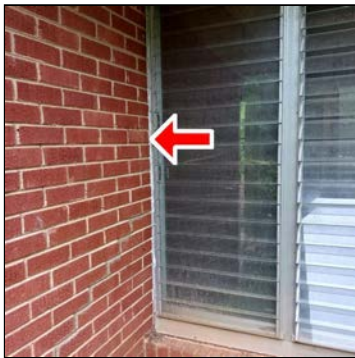
Front left

2.4 Observed multiple locations where caulk sealing is needed where the brick veneer meets the vinyl / wood / metal trim (See photos for locations). Condition is conducive to potential water penetrations and other damage. Evaluation / Correction by a qualified handyman contractor is recommended for this entire condition.

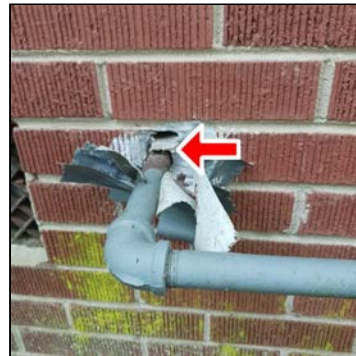
2.4 Observed that caulk sealing is needed at all pipes / wires where they pass through the house wall (See photos for locations). Condition is conducive to potential water penetrations and other damage. Evaluation / Correction by a qualified handyman contractor is recommended for this entire condition.

Right side gas line

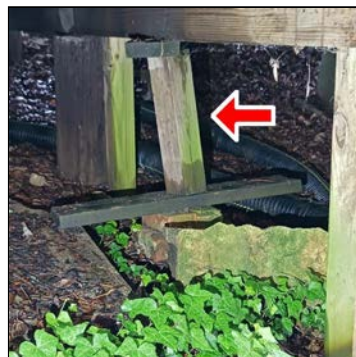
2.10 Observed improperly supported columns underneath the rear deck. These columns are leaning and lacking proper footings underneath them which can lead to structural movement. Evaluation / Correction by a qualified general contractor is recommended for this entire condition.

Missing column footings

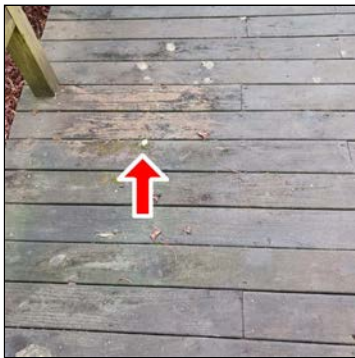
Rear deck

2.10 Observed decking and railings to have cracked / deteriorated materials in various areas and some nails are backing out. Repair / replace cracked and deteriorated materials as needed and for weathered deck surfaces we recommend sealing wood as needed and resetting nails. Condition is conducive to further damages. Evaluation / Correction by a qualified general / handyman contractor is recommended for this entire deck / condition.

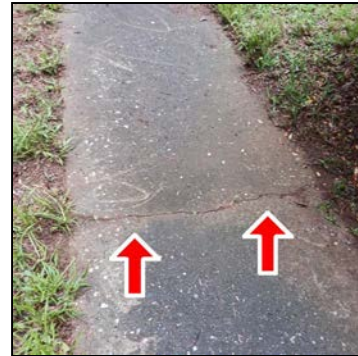
Front sidewalk

3.0 Observed typical cracking at the front sidewalk due to age and typical masonry shrinkage. No displacement was observed at the time of inspection. Recommend sealing of cracks as needed / desired and then subsequent observation.

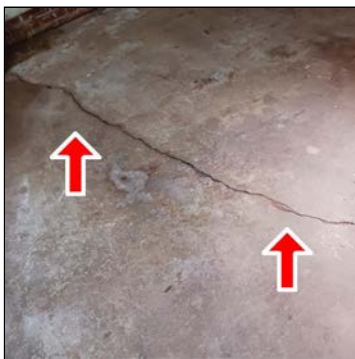
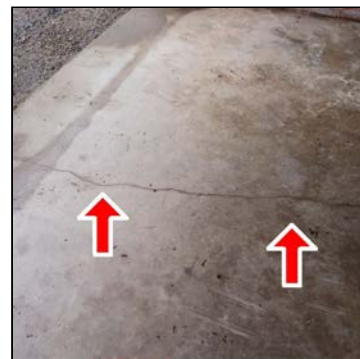
4.0 Observed sections of the garage floor that are raised up with some displacement. Although concrete movement and typical cracking is common in almost every home this condition poses a safety (tripping) hazard. Evaluation / Correction by a qualified general / concrete contractor is recommended for this entire condition.

Garage slab cracks

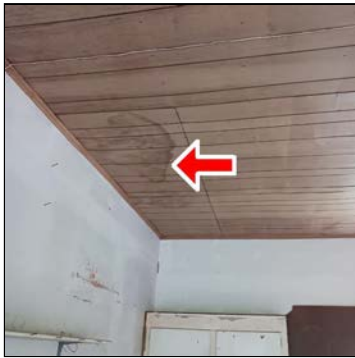
Garage ceiling

4.1 Observed water stains and damaged areas in the garage ceiling and walls in multiple locations. These stains are likely from previous roof leaks and damages. Evaluation / Correction by a qualified general contractor is recommended for this entire condition.

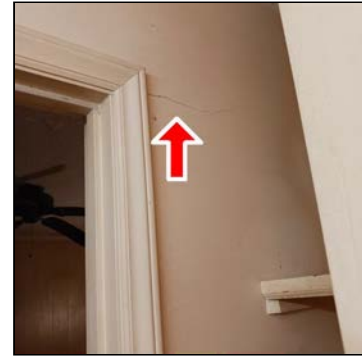
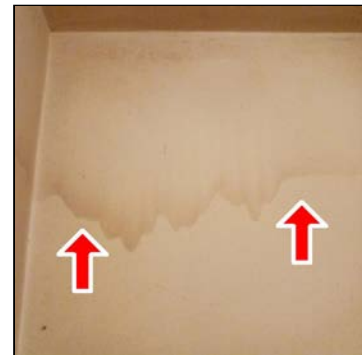
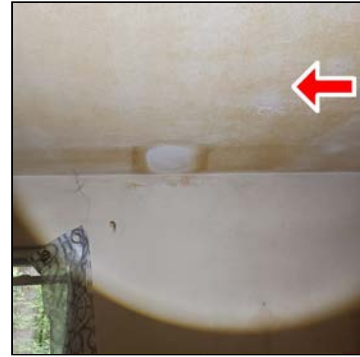
Damages throughout

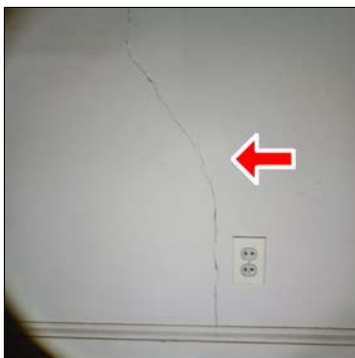
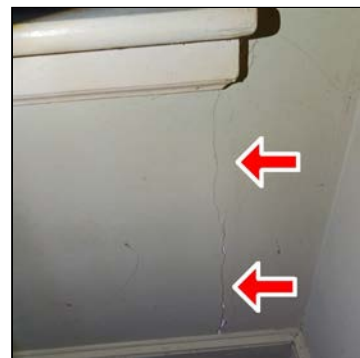
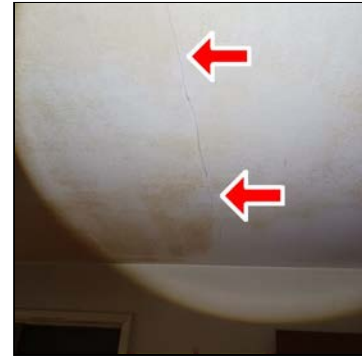
7.0 Observed multiple drywall cracks with some displacement throughout the home. Some of these cracks appear to be structural in nature and need further review. Evaluation / Correction by a qualified general contractor / structural engineer is recommended for this entire condition.

Displaced drywall cracks throughout

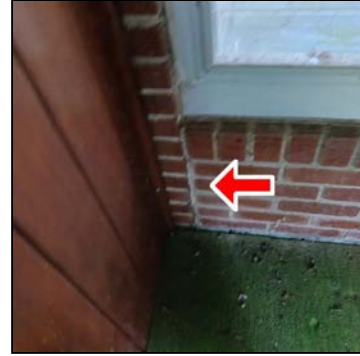
Visible daylight in garage walkway walls

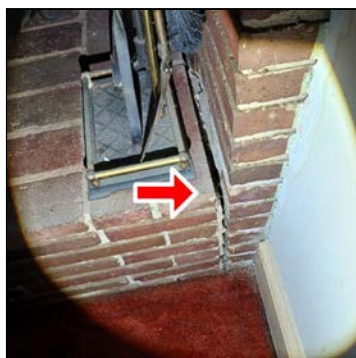
7.9 Observed a large gap between the fireplace hearth and the chimney. This may be an indication that the chimney has moved and separated itself from the home. Condition is conducive to further damages. Evaluation / Correction by a qualified general contractor is recommended for this entire condition.

Large gaps at base of fireplace

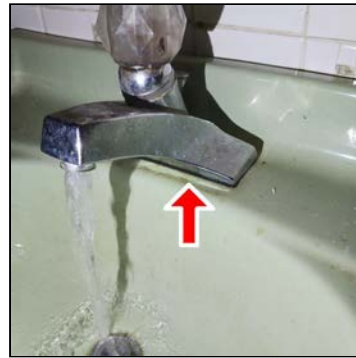
8.0.B Observed that the hall bathroom sink leaks at the base. Condition is conducive to further damages. Evaluation / Correction by a qualified plumbing contractor is recommended for this entire condition.

Hall bath sink leaks

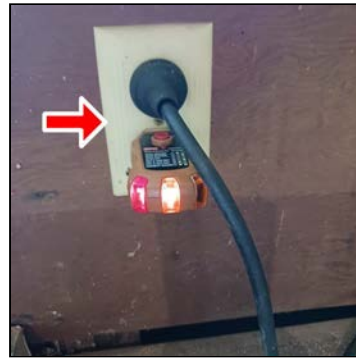
Garage

9.6 Observed an outlet that tested for reversed polarity (hot & neutral wires reversed) in the rear of the garage. Condition is conducive to a safety hazard. Evaluation / Correction by a qualified electrical contractor is recommended for this entire condition.

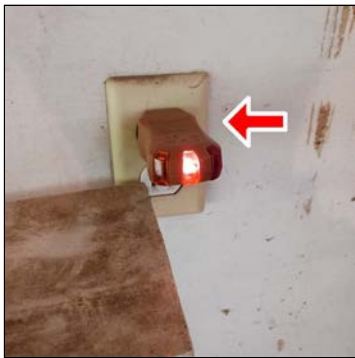
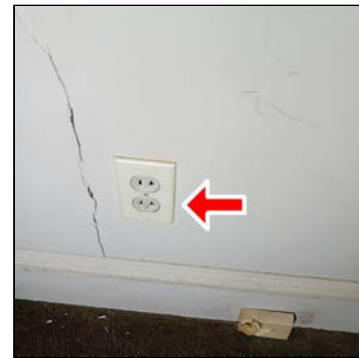
Ungrounded outlets throughout

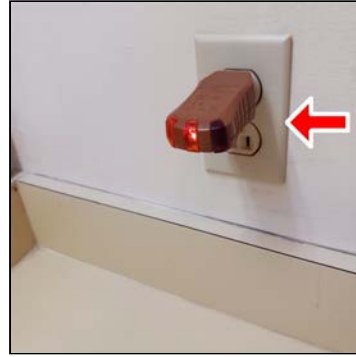
No GFCIs in bath, kitchen or exterior outlets

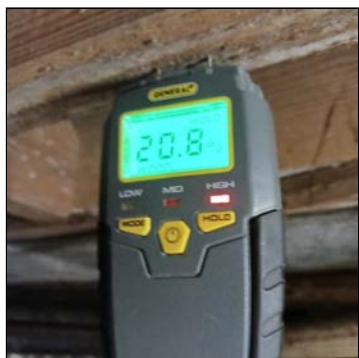
High moisture levels

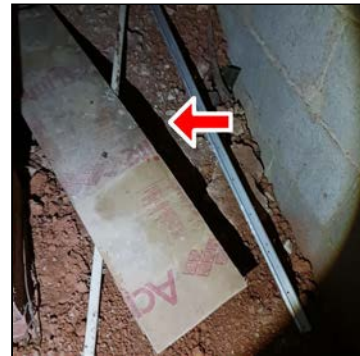
Trash in crawl space
