This home is not sweat equity fun project or a “lipstick on a pig flip.”

The home has serious issues/repairs that need a seasoned contractor with a knowledgeable team to figure out assessing and fixing to have the ability to grow equity and maximize its potential and profit.

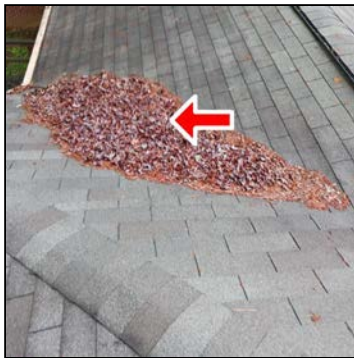
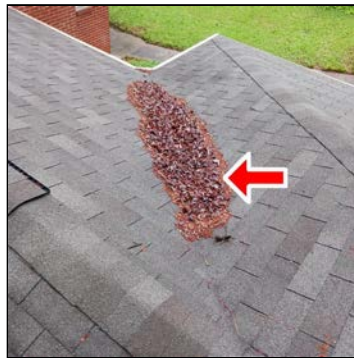
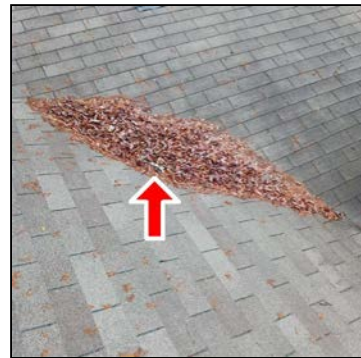
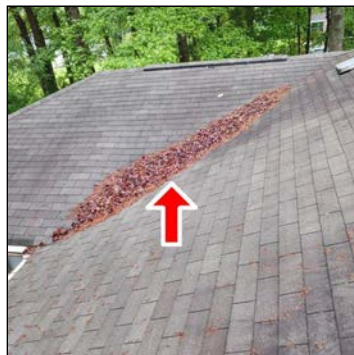
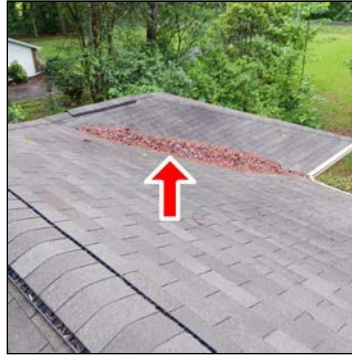
Observed excessive tree debris build up in the valleys at several areas around the roof that need to be removed. This can cause water to back up and penetrate under the shingles and into the home. Evaluation / Correction by a qualified handyman contractor is recommended for this entire condition.

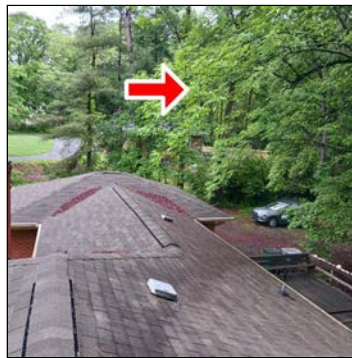
Observed several tree limbs that are in contact with roof or hanging near roof that should be trimmed back (See photos for locations). This is a condition conducive to advanced roof wear and possible damages to other building materials. Evaluation / Correction by a qualified handyman contractor is recommended for this entire condition.

Overhanging branches

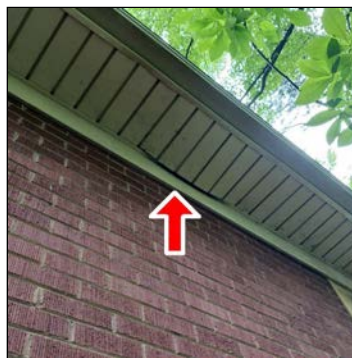
Right side

Observed that the vinyl soffit was pulled down at the right side. Condition is conducive to potential rodent penetrations and other damages. Evaluation / Correction by a qualified handyman contractor is recommended for this entire condition.

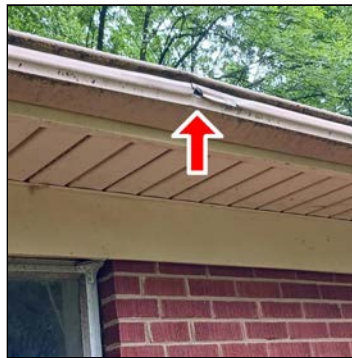
Front left

Observed a section of gutter at the front left side that has been damaged and needs to be repaired. Condition is conducive to further damages. Evaluation / Correction by a qualified gutter contractor is recommended for this entire condition.

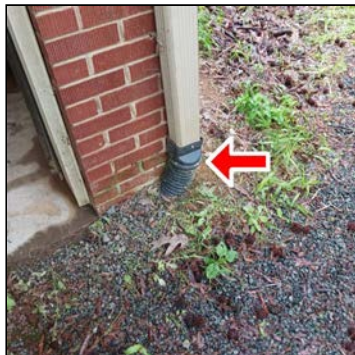
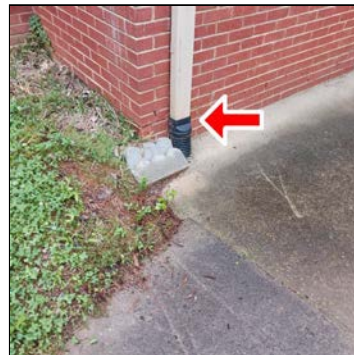
Downspouts that run into the ground are subject to backup / blockage. Neither the presence nor integrity of underground lines, nor free flow of water through such lines is determinable as part of this inspection.

Underground downspouts

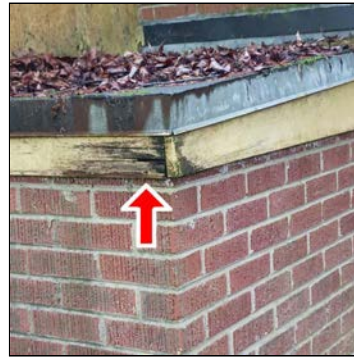
Rear

Observed damage and deterioration at multiple areas of the siding and wood trim, see photos for

locations. We also observed multiple areas where the siding is gaped around windows, doors, and other trim components. Areas that were observed are from ground level (only) but there may be additional repairs needed higher up and / or out of view. Recommend wood repair / replacement / caulking / painting to protect from the elements and prevent water penetrations / other damages. Evaluation / Correction by a qualified siding contractor is recommended for the entire wood exterior condition.

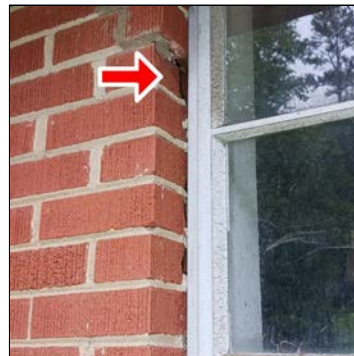
Observed multiple areas of separation at the front left breezeway window and the brick veneer. This may be caused by a settling condition or brick pulling away in this area. Condition is conducive to further damages and potential water penetrations. Evaluation / Correction by a qualified general contractor is recommended for this entire condition.

Front left window gap

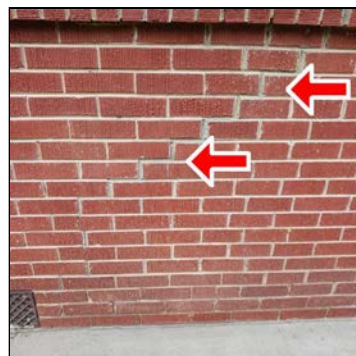
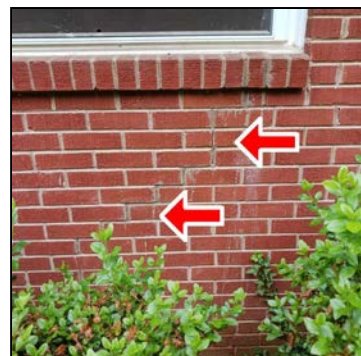
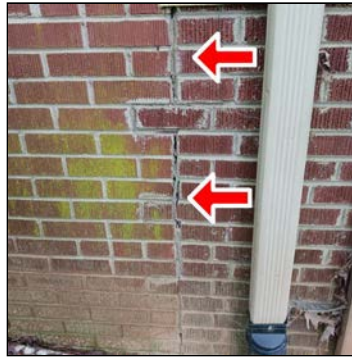
Observed a stair step crack in the brick veneer at multiple locations around the home with some displacement evident (See photos for locations). Condition is conducive to further damages. Evaluation / Correction by a qualified general / masonry contractor is recommended for this entire condition.

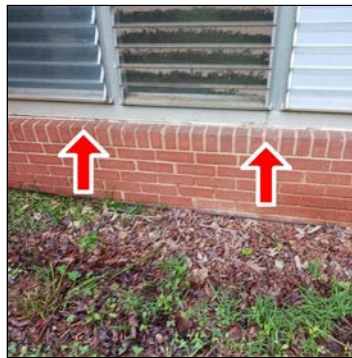
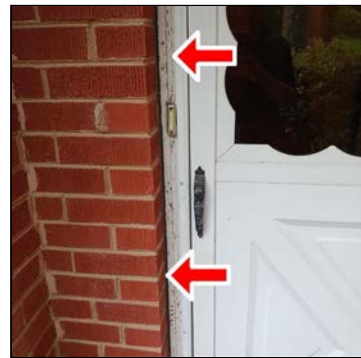
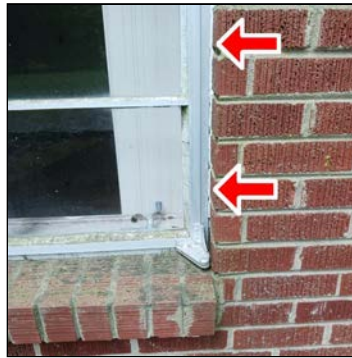
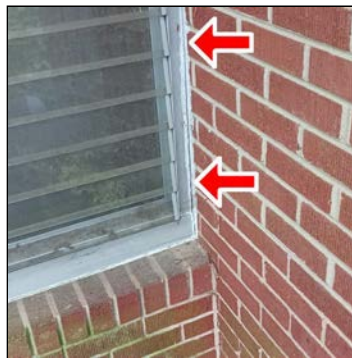
Observed multiple locations where caulk sealing is needed where the brick veneer meets the vinyl / wood / metal trim (See photos for locations). Condition is conducive to potential water penetrations and other damage. Evaluation / Correction by a qualified handyman contractor is recommended for this entire condition.

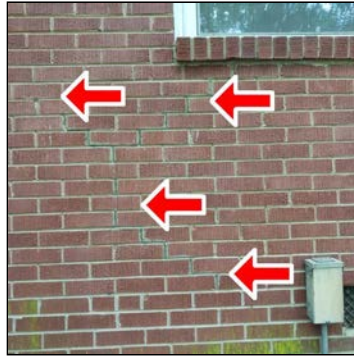
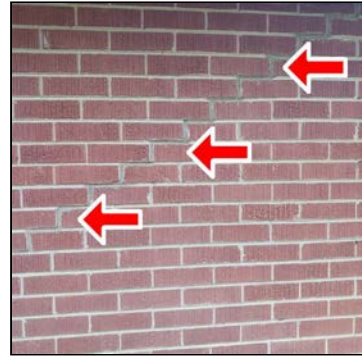
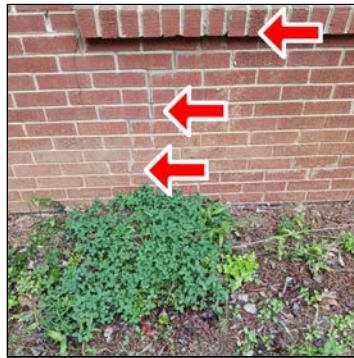
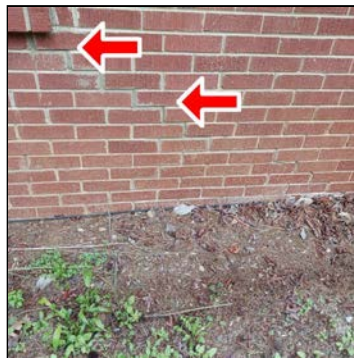
Observed small cracks in the brick veneer at several locations (See photos for locations). These are typical in nature due to age and normal masonry shrinkage. Although small cracks in brick veneers

are typical, these areas should be resealed too prevent any water penetrations or damages and subsequently monitored. Evaluation / Correction by a qualified handyman contractor is recommended for this entire condition.

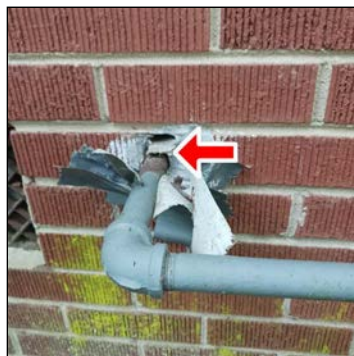
Observed that caulk sealing is needed at all pipes / wires where they pass through the house wall (See photos for locations). Condition is conducive to potential water penetrations and other damage. Evaluation / Correction by a qualified handyman contractor is recommended for this entire condition.

Right side gas line

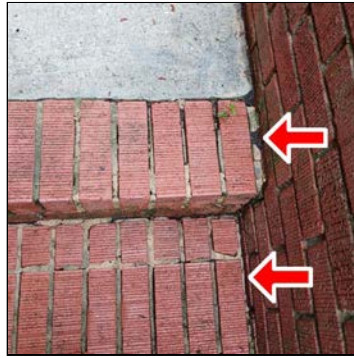
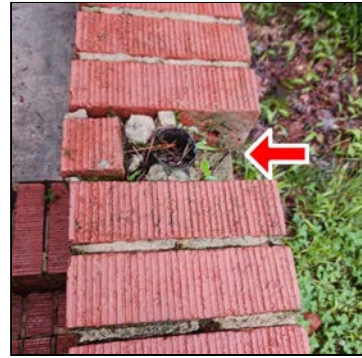
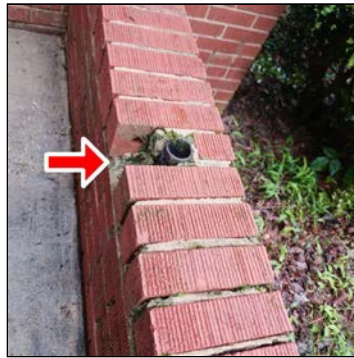
Observed open mortar joints and loose bricks at the front steps in several locations. All open mortar joints need to be sealed to prevent water penetrations. Condition is conducive to further damages. Evaluation / Correction by a qualified handyman contractor is recommended for this entire condition.

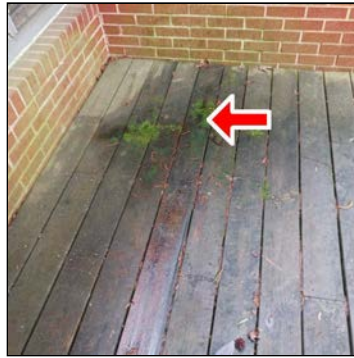
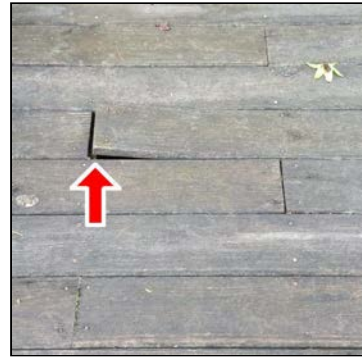
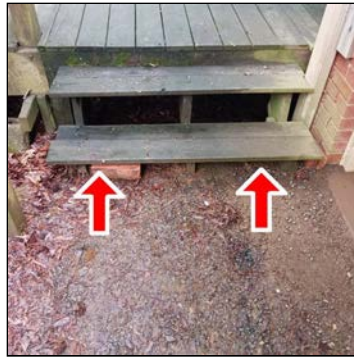
Observed decking and railings to have cracked / deteriorated materials in various areas and some nails are backing out. Repair / replace cracked and deteriorated materials as needed and for weathered deck surfaces we recommend sealing wood as needed and resetting nails. Condition is conducive to further damages. Evaluation / Correction by a qualified general / handyman contractor is recommended for this entire deck / condition.

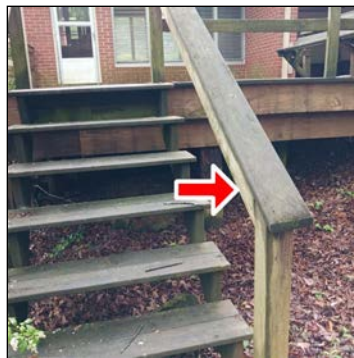
Observed loose railings at the bottom of the rear deck posts. Condition is conducive to potential safety concerns. Evaluation / Correction by a qualified handyman contractor is recommended for this entire condition.

Rear deck step railing
loose

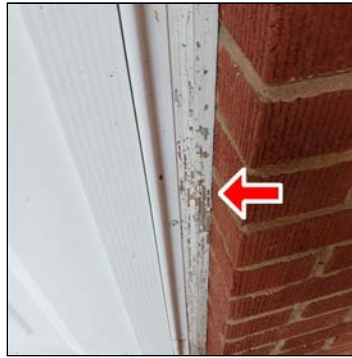
Observed chipping / cracking and the possibility of lead based paint at various areas of the exterior. Lead based paint in homes built prior to 1979 is very common. This was a standard practice at the time that the home was built. There have been many documented concerns with regards to the potential safety hazards of lead based paint when it is chipping / peeling and cracked. Client is advised to seek consultation from a qualified contractor in regards to treating these conditions.

Possible lead based paint

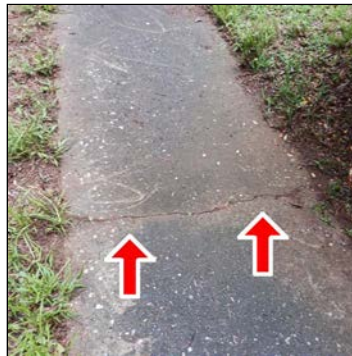
Front sidewalk

Observed typical cracking at the front sidewalk due to age and typical masonry shrinkage. No displacement was observed at the time of inspection. Recommend sealing of cracks as needed / desired and then subsequent observation.

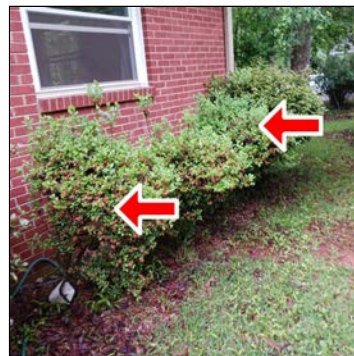
Vegetation

Observed vegetation that is in direct contact with building materials. This is a condition conducive to further damages. Cutting back at least 12 inches is recommended. Evaluation / Correction by a qualified handyman contractor is recommended for this entire condition.

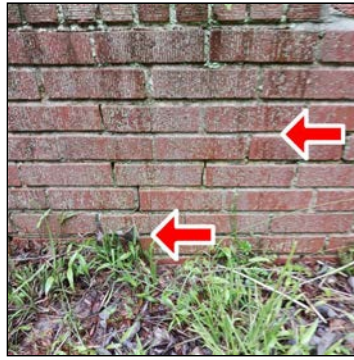
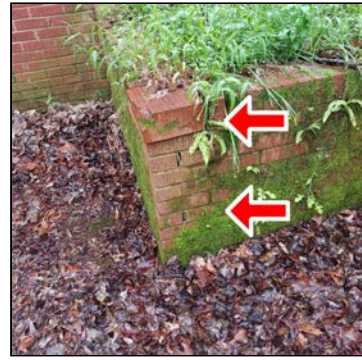
Observed multiple retaining walls that are leaning and have areas of displacement in the brick.

Condition is conducive to further retaining wall failures over time. Evaluation / Correction by a qualified general contractor is recommended for this entire condition.

Front retaining wall

Rear retaining walls

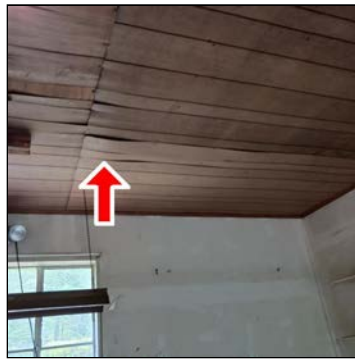
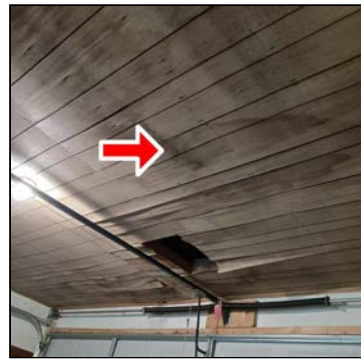
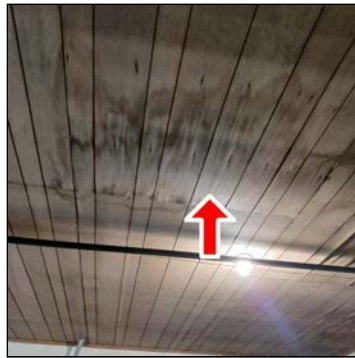
Observed water stains and damaged areas in the garage ceiling and walls in multiple locations. These stains are likely from previous roof leaks and damages. Evaluation / Correction by a qualified general contractor is recommended for this entire condition.

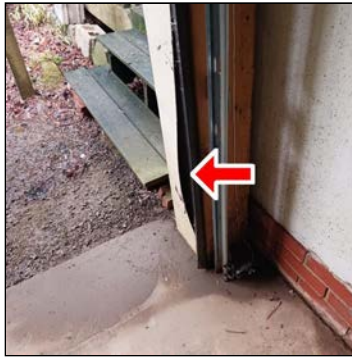
Observed an area of loose trim around the exterior of the garage door. Evaluation / Correction by a qualified handyman contractor is recommended for this entire condition.

Loose trim around garage door

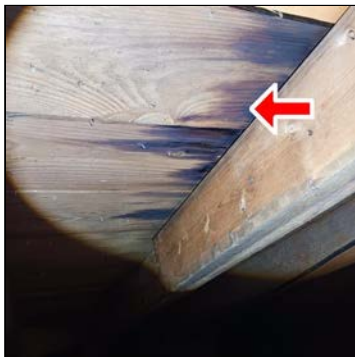
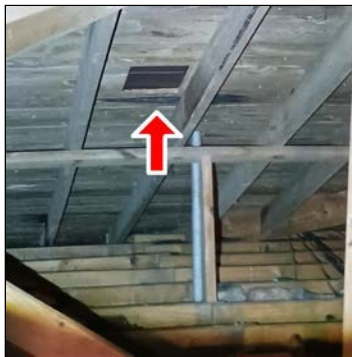
Front

Observed water stained and damaged roof sheathing at the front and rear attic that needs to be repaired / replaced (See photos). Condition is conducive to further damages / roof leaks. Evaluation / Correction by a qualified general / roofing contractor is recommended for this entire condition.

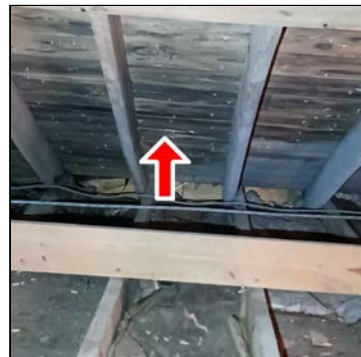
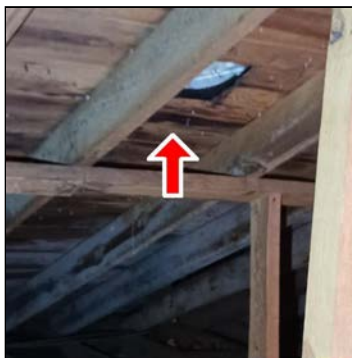
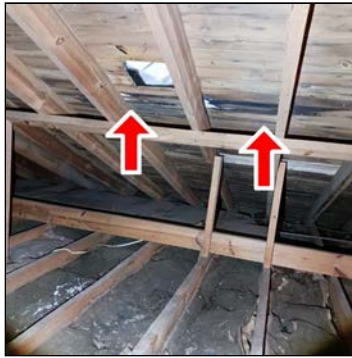
Rear

BEING FIXED 5/24 Plumbing boot leak

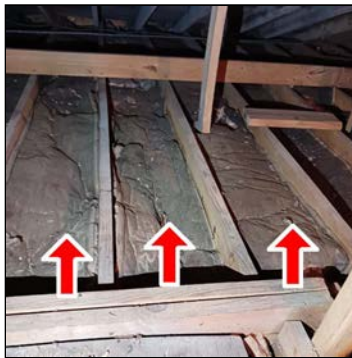
Observed attic insulation that is moved / compressed in various areas throughout. Condition is conducive to Heat / AC loss. Evaluation / Correction by a qualified handyman contractor is recommended for this entire condition.

Compressed insulation in attic

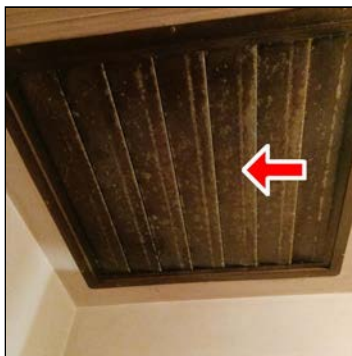
Observed that the attic vent fan did turn on during testing but the vent fan flaps did not open as intended. Evaluation / Correction by a qualified electrical contractor is recommended for this entire condition.

Vent fan flaps

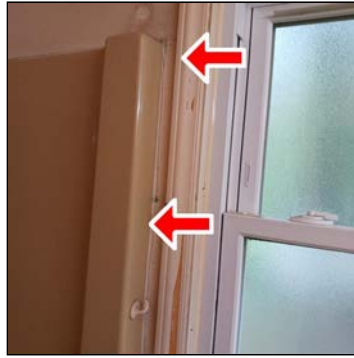
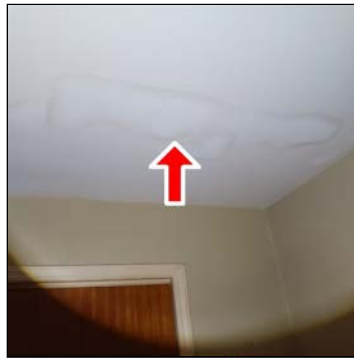
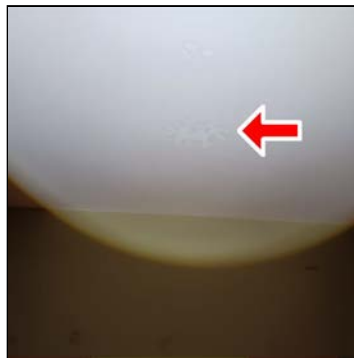
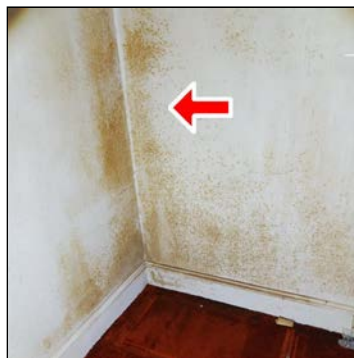
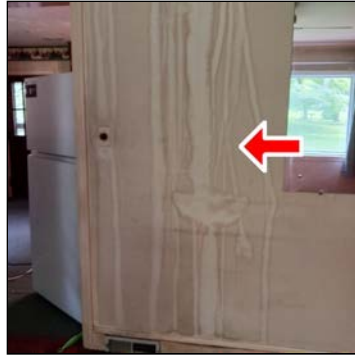
Observed extensive drywall cracks, water stains, damaged ceilings and smoke damages throughout the home. Condition is conducive to further damages. Evaluation / Correction by a qualified general contractor is recommended for this entire condition.

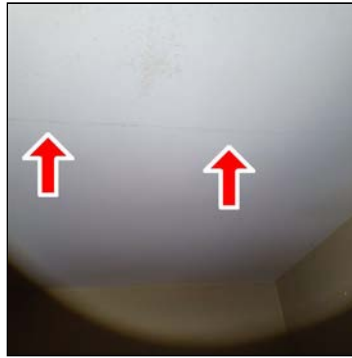
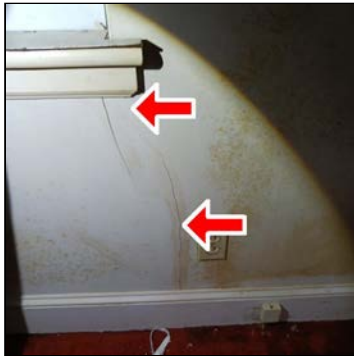
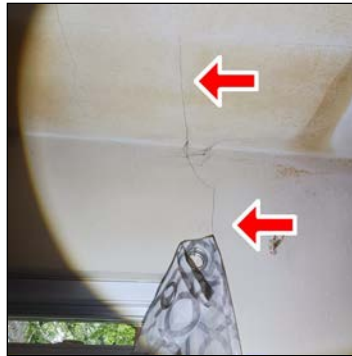
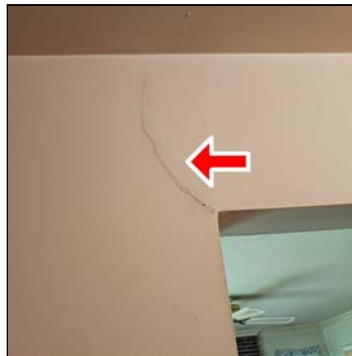
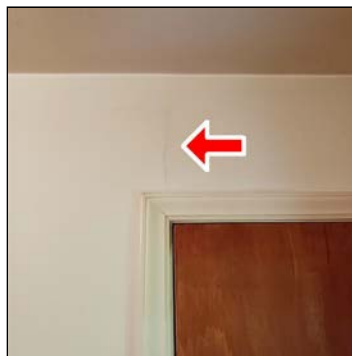
Observed multiple drywall cracks with some displacement throughout the home. Some of these cracks appear to be structural in nature and need further review. Evaluation / Correction by a qualified general contractor / structural engineer is recommended for this entire condition.

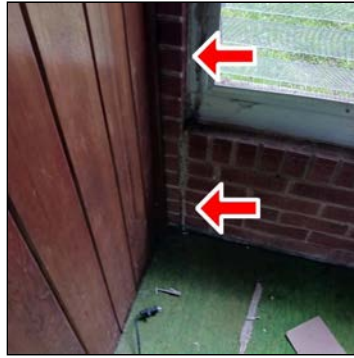
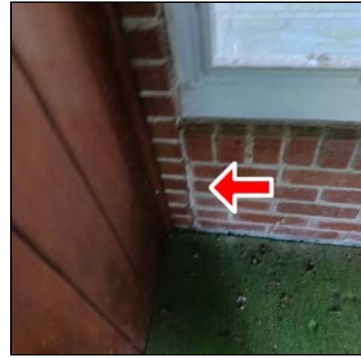
Observed gaps in the brickwork with visible daylight in the walkway between the garage and the house. Condition is conducive to further damages / water penetrations. Evaluation / Correction by a qualified general contractor is recommended for this entire condition.

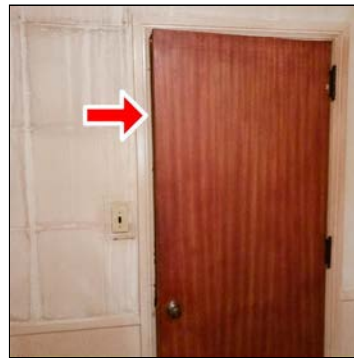
Master bedroom

Observed that several of the room and closet doors hit and rub the door frames, see photos for locations. This is typically due to expansion and contraction from seasonal interior humidity. (Recommend checking all in all locations) Evaluation / Correction by a qualified handyman contractor is recommended for this entire condition.

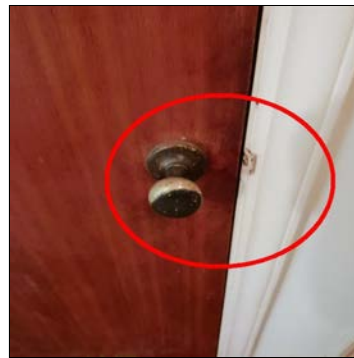
Hall closet

Observed that several of the room and closet doors have malfunctioning hardware that will not latch correctly, see photos for locations. This is typically due to expansion and contraction from seasonal interior humidity. (Recommend checking all in all locations) Evaluation / Correction by a qualified handyman contractor is recommended for this entire condition.

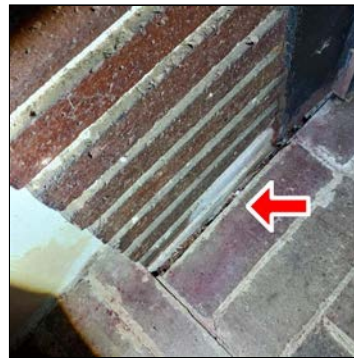
Observed a large gap between the fireplace hearth and the chimney. This may be an indication that the chimney has moved and separated itself from the home. Condition is conducive to further damages. Evaluation / Correction by a qualified general contractor is recommended for this entire condition.

Large gaps at base of fireplace

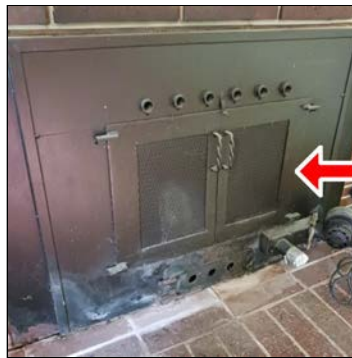
Observed a heavy soot on the throat of the fireplace chimney. Due to a height restrictions / chimney caps and other finished materials the inside of the chimney flue was not readily accessible for inspection. I/We recommend all fireplace components be cleaned and further evaluated before next use. Conditions are conducive to further damages and potential safety concerns. Evaluation / Correction by a qualified fireplace contractor is recommended for this entire condition.

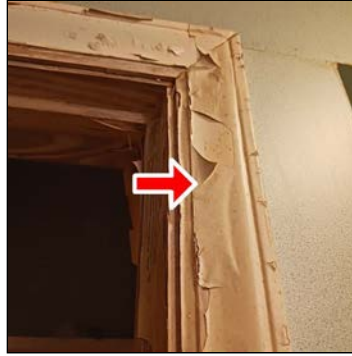
There is a likely probability that there is lead based paint throughout the interior of the home. This was a standard practice at the time that the home was built. Lead based paint in homes built prior to

1979 is very common. There have been many documented concerns with regards to the potential safety hazards of lead based paint when it is chipping / peeling and cracked. Client is advised to seek consultation from a qualified contractor in regards to treating these conditions.

Possible lead based paint

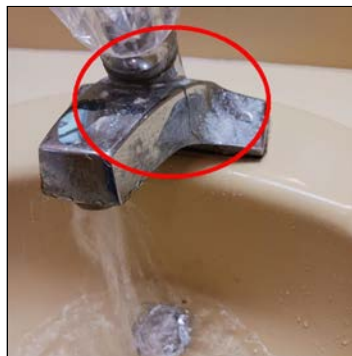
Observed that the master bathroom sink leaks at the faucet handle. Condition is conducive to further damages. Evaluation / Correction by a qualified plumbing contractor is recommended for this entire condition.

Leaks

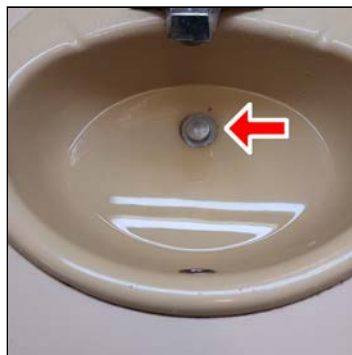
Observed that the master bathroom sink is slow to drain. This is likely caused by a clog. Evaluation / Correction by a qualified plumbing contractor is recommended for this entire condition.

Master sink slow drain

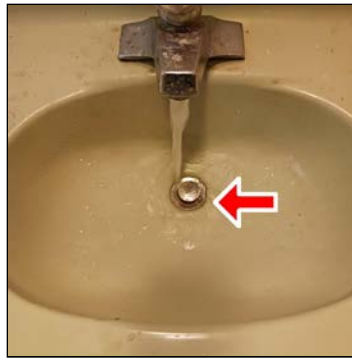
Observed that the master bath drain stopper did not function properly / did not hold water. Evaluation / Correction by a qualified plumbing contractor is recommended for this entire condition.

Hall bath sink stopper

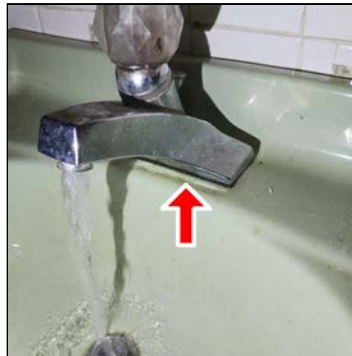
Observed that the hall bathroom sink leaks at the base. Condition is conducive to further damages. Evaluation / Correction by a qualified plumbing contractor is recommended for this entire condition.

Hall bath sink leaks

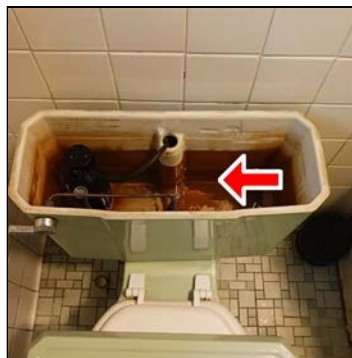
Observed that the hall bathroom toilet did not refill after being flushed. It may be that the water is turned off to the toilet or other issues. Evaluation / Correction by a qualified plumbing contractor is recommended for this entire condition.

Hall bath toilet

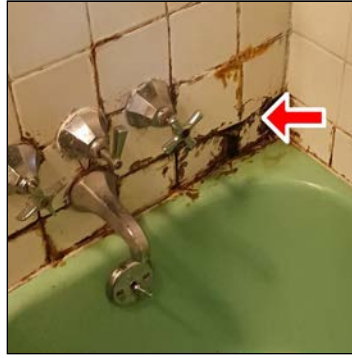
Observed severely damaged tile work around the hall bathroom tub walls. This may be from past or current plumbing leaks and a lack of maintenance. Evaluation / Correction by a qualified general contractor is recommended for this entire condition.

Hall bathtub tile walls

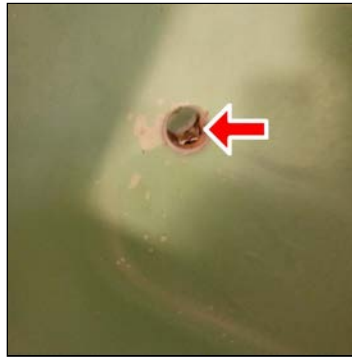
Observed chips and damages in the hall bathroom tub base. Condition is conducive to further damages. Evaluation / Correction by a qualified general contractor is recommended for this entire condition.

Tub base

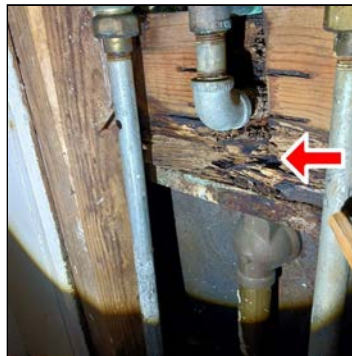
Observed areas of rot / decay behind the hall bathroom tub from a past or current leak. Evaluation / Correction by a qualified general / plumbing contractor is recommended for this entire condition.

Behind hall bathroom tub

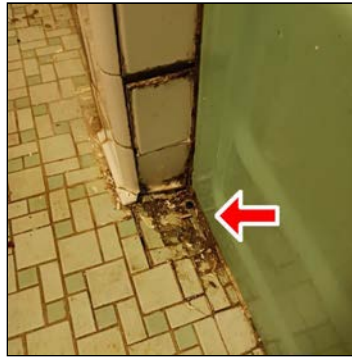
Observed damaged / Collapsed flooring on the exterior of the hall bathroom tub. Condition is conducive to further damages. Evaluation / Correction by a qualified general contractor is recommended for this entire condition.

Damaged floor hall bathroom

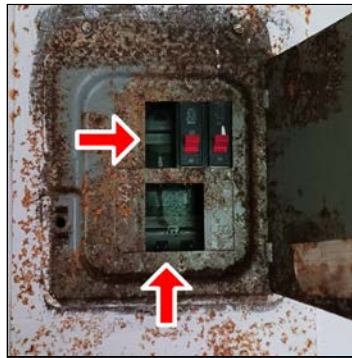
Basement panel

Observed several knockouts that were removed at the basement sub panel. All holes in the side or the front cover of the panel needs to be plugged / covered. Condition is conducive to potential safety concerns. Evaluation / Correction by a qualified electrical contractor is recommended for this entire condition.

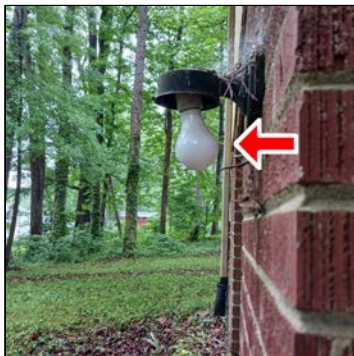
Basement entry door

Observed that several lights in various locations did not function (See photos for locations). Recommend bulb replacement to ensure proper function first. If not bulb then Evaluation / Correction by a qualified electrical contractor may be necessary.

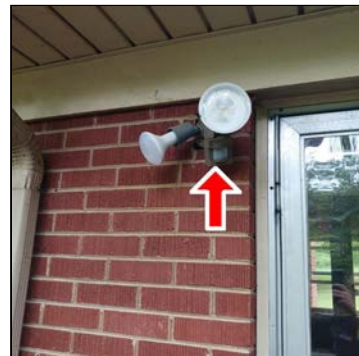
Rear deck

seller said this light was on when they were there a few months ago. Probably left on for months and just needs a bulb

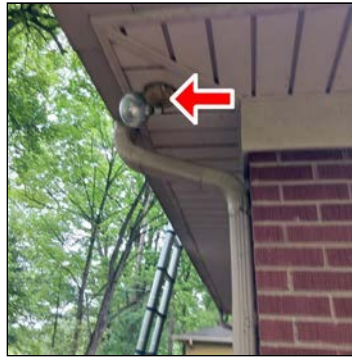
Rear left

This light is controlled by switch

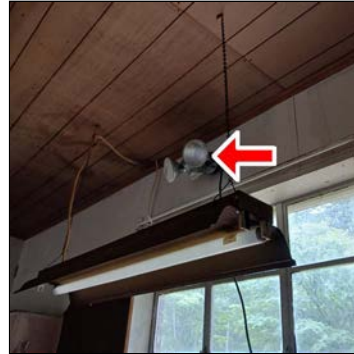
Garage is a motion light that should come on when you enter the door. Seller says it is probably shot and needs a new fixture

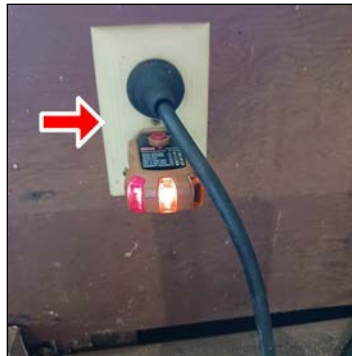
Garage

Observed an outlet that tested for reversed polarity (hot & neutral wires reversed) in the rear of the garage. Condition is conducive to a safety hazard. Evaluation / Correction by a qualified electrical contractor is recommended for this entire condition.

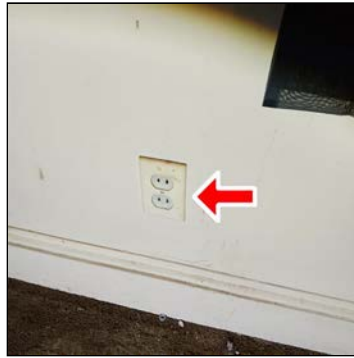
Observed electrical outlets in multiple areas that tested to have an either no / open or broken ground throughout the home. Condition is conducive to potential safety hazards. Evaluation / Correction by a qualified electrical contractor is recommended for this entire condition.

Ungrounded outlets throughout

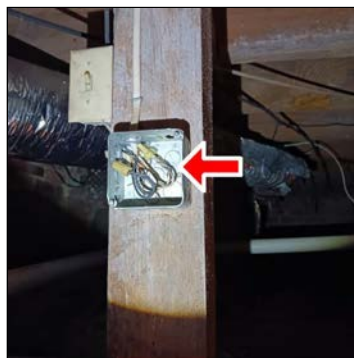
Observed improperly terminated wiring in the crawl space. These wires need to be properly installed inside a junction box and covered. Condition is conducive to a potential safety hazard. Evaluation / Correction by a qualified electrical contractor is recommended for this entire condition.

Missing junction box cover in crawl

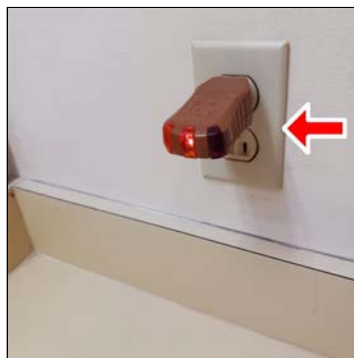
Observed no GFCI protection at any of the bathroom, kitchen or exterior outlets. At the time when the home was built it was not required to have GFCI protection on these outlets. However if devices are to be or have been changed or upgraded it would be required to be brought up to today's standards. Client may consider adding in the future. Condition is conducive to a safety hazard. Evaluation / Correction by a qualified electrical contractor is recommended for this entire condition.

No GFCIs in bath, kitchen or exterior outlets

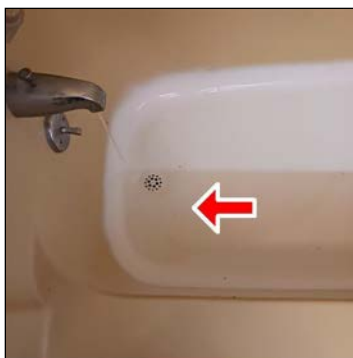
Observed discolored / stained water coming out of the tub and sink faucets. It is likely that the water heater has sediment or rust deposits in it. Condition is conducive to other potential damages. Evaluation / Correction by a qualified plumbing contractor is recommended for this entire condition.

Discolored water

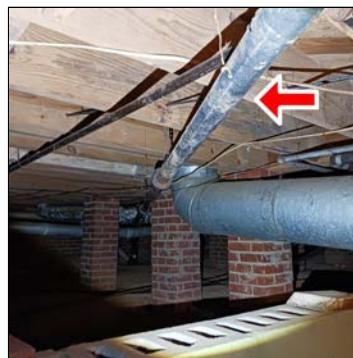
Observed that portions of the plumbing drain system are cast iron piping. Although no visible leaks were found at the time of inspection, cast iron piping can corrode in areas that are not visible. Also the rubber band boots that are used for connections are prone to leaking. Evaluation / Correction by a qualified plumbing contractor is recommended for this entire condition.

Cast iron pipes

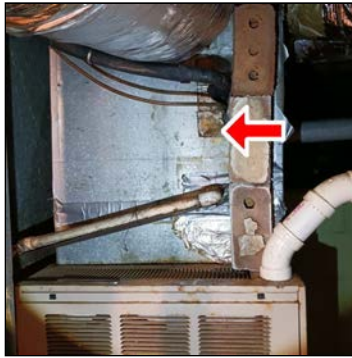
Per the standards of practice all NC / SC home inspectors are only required / allowed to remove readily accessible panels for inspection. In regards to the indoor coil units some of these panels cannot be removed due to design / obstructions / seal tape and or mastic compound. These indoor coil units work in tandem with the condenser unit outside to produce the air conditioning. Although temperature readings indicate that the unit was functioning properly at the time of inspection, it is recommended that a qualified HVAC contractor further evaluate due to no service information revealed / given to FSHI at the time of inspection.

HOME NEEDS NEW AC SYSTEM

Indoor coil not inspected

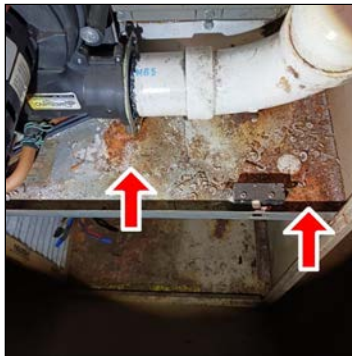
Observed areas of rust inside the furnace burner cabinet. This is likely from age and lack of maintenance. Condition is conducive to further damages. Evaluation / Correction by a qualified HVAC contractor is recommended for this entire condition.

Rust

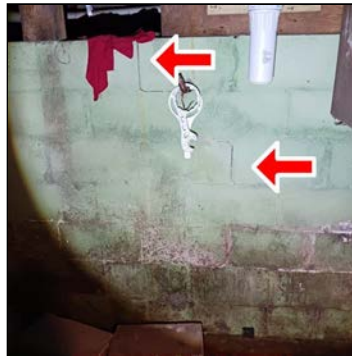
Observed a crack in the basement foundation wall at the right side with some displacement (significant movement) visible. It is likely that this condition has existed for an extended period of time. These areas should be sealed too prevent any water penetrations or further damages. Evaluation / Correction by a qualified general contractor is recommended for this entire condition.

Basement wall crack

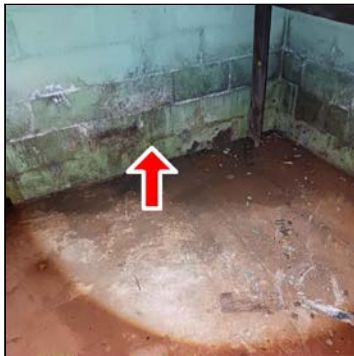
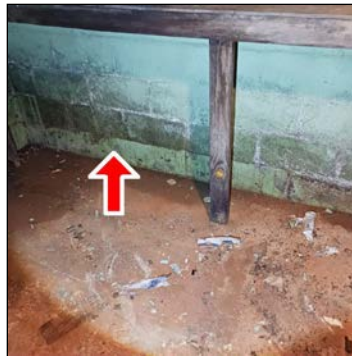
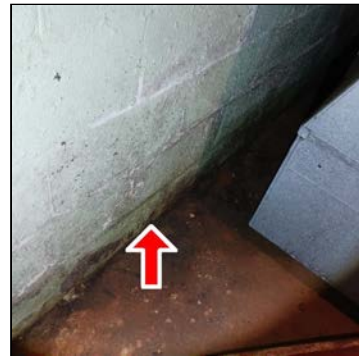
Basement walls near furnace / water heater

Observed water stains and wet areas at the bottom of the basement / crawlspace walls. This is evidence of water penetrations in this area which can lead to high moisture levels and other issues. Evaluation / Correction by a qualified general contractor is recommended for this entire condition.

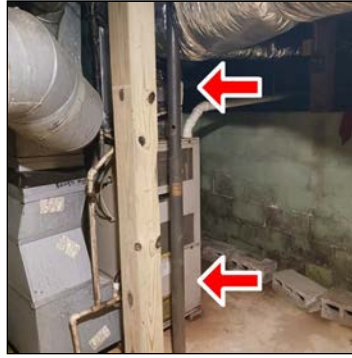
Observed a commercial grade metal jack stud that has been used as a pier in lieu of the typical masonry block pier. These jack studs are being used to support all of the drop girder beams in the crawlspace section of the house. Metal jack studs are acceptable in some applications but they must be installed exactly according to the manufacturers installation instructions. Evaluation / Correction by a qualified contractor / structural engineer is recommended for this entire condition.

Metal jack stud

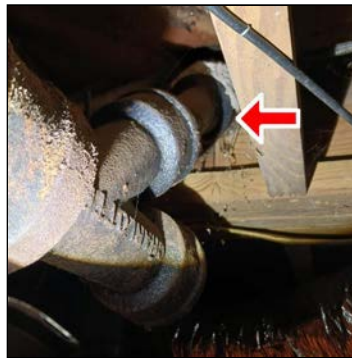
Observed that the girder in the rear of the crawl space has been cut / damaged for plumbing drain lines. Condition is conducive to further structural damages / failures. Evaluation / Correction by a qualified general contractor / structural engineer is recommended for this entire condition.

Rear girder cut

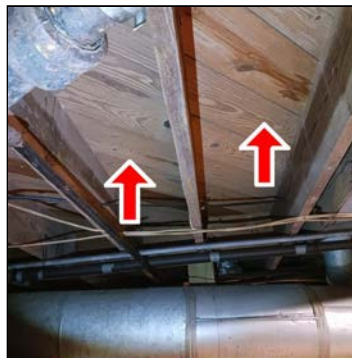
Although not a requirement at the time the home was built the client may consider adding insulation in the floor system for added efficiency to reduce heating and cooling capacities.

No insulation

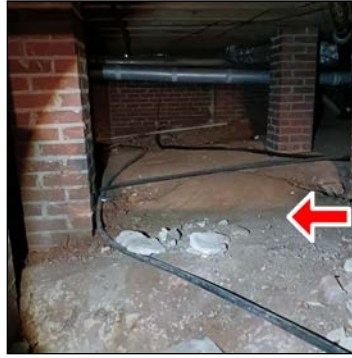
Observed no moisture barrier in the crawl space. Moisture barriers keep under ground moisture from entering the crawl space area. Condition is conducive to high moisture content, which in turn is conducive to wood destroying insects / fungi growth and other potential concerns. It is highly recommend that a 6 mil ploy plastic be installed and covering 100% of the dirt area. Evaluation / Correction by a qualified contractor is recommended for this entire condition.

No moisture barrier

\$5327 Crawl Space Mold repair/vapor barrier/drylock foundation

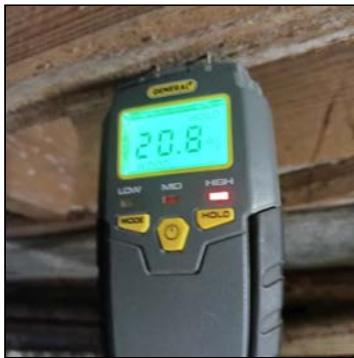
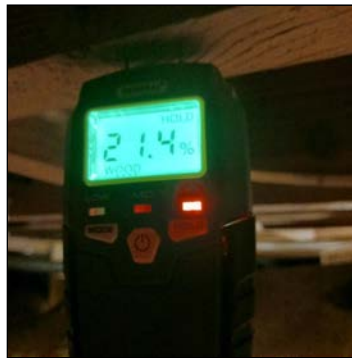
Observed a high moisture condition all throughout the crawl space. This condition is conducive to wood rot / decay, wood destroying insects and also mildew / fungus growth. Moisture readings in the substructure were at unacceptable levels from 20% to 25% at the time of inspection and evidence shows that the condition worsens during the warmer months of the year. Evidence of active and inactive fungi conditions was observed through out most of the crawlspace area. There was also evidence of water penetrations and wet soil in the crawl space / basement. Evaluation / Correction by a qualified fungi remediation and general contractor is recommended for this entire condition.

High moisture levels

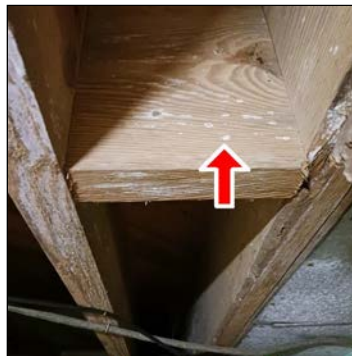
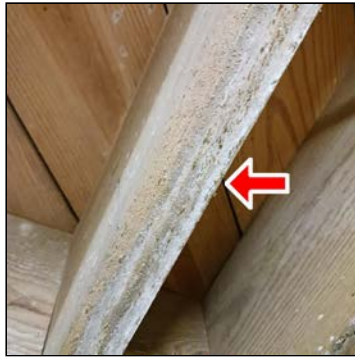
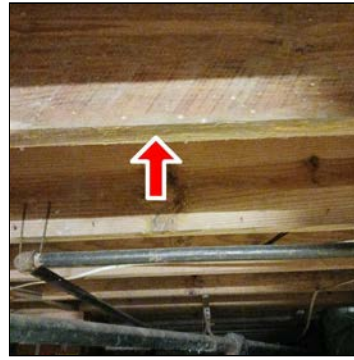
Fungi

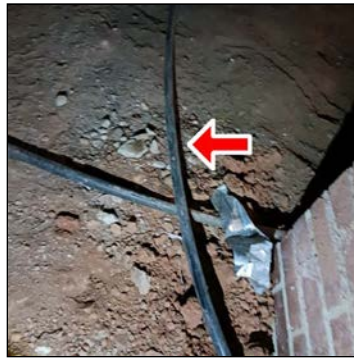
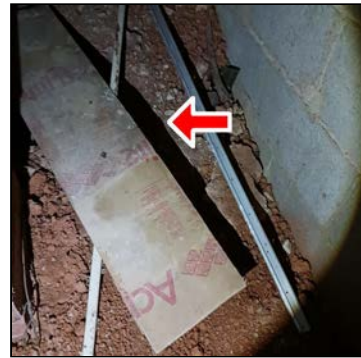
Observed wood debris and other trash items in the crawl space. All wood, trash or cardboard debris must be kept out of crawl space areas. Condition is conducive to wood destroying insects and other potential concerns. Evaluation / Correction by a qualified handyman contractor is recommended for this entire condition.

Trash in crawl space

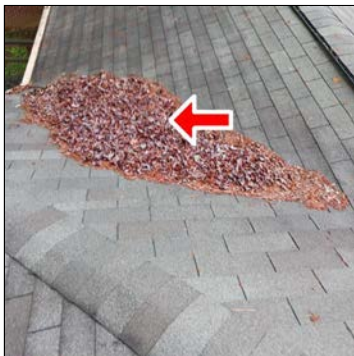
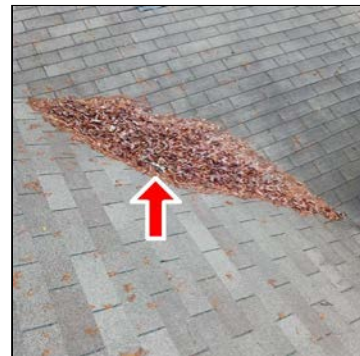
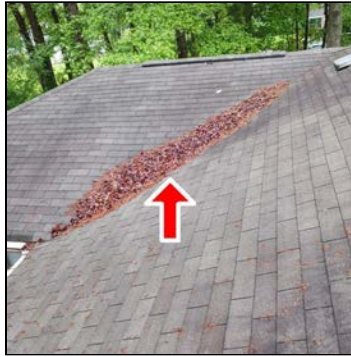
Rear

1.0 Observed excessive tree debris build up in the valleys at several areas around the roof that need to be removed. This can cause water to back up and penetrate under the shingles and into the home. Evaluation / Correction by a qualified handyman contractor is recommended for this entire condition.

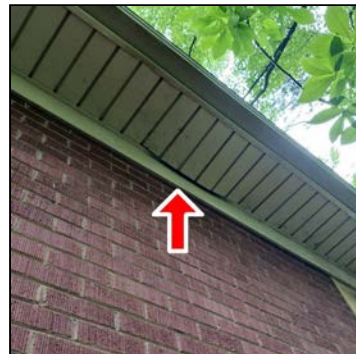
Right side

1.1 Observed that the vinyl soffit was pulled down at the right side. Condition is conducive to potential rodent penetrations and other damages. Evaluation / Correction by a qualified handyman contractor is recommended for this entire condition.

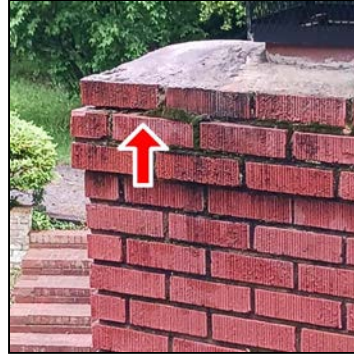
1.3 Observed cracked areas of the chimney mortar cap and open areas between cap and flue liner. Condition is conducive to water penetrations at interior of chimney / fireplace. Seal with proper

Chimney cracks

material to avoid water penetrations. Evaluation / Correction by a qualified chimney contractor is recommended for this entire condition.

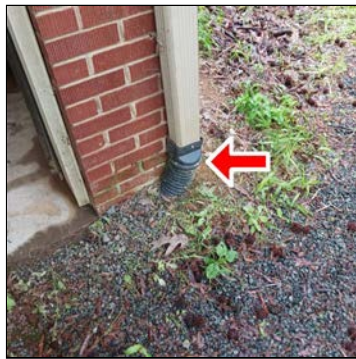
1.6 Downspouts that run into the ground are subject to backup / blockage. Neither the presence nor integrity of underground lines, nor free flow of water through such lines is determinable as part of this inspection.

Underground downspouts

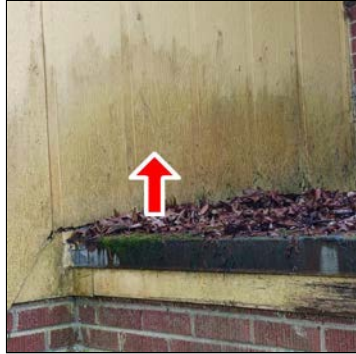
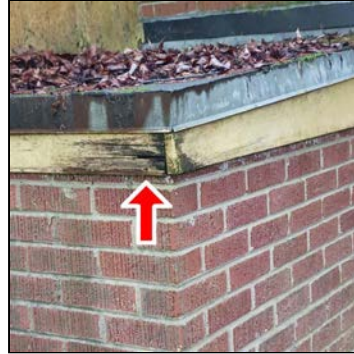
Rear

2.3 Observed damage and deterioration at multiple areas of the siding and wood trim, see photos for locations. We also observed multiple areas where the siding is gaped around windows, doors, and other trim components. Areas that were observed are from ground level (only) but there may be additional repairs needed higher up and / or out of view. Recommend wood repair / replacement / caulking / painting to protect from the elements and prevent water penetrations / other damages. Evaluation / Correction by a qualified siding contractor is recommended for the entire wood exterior condition.

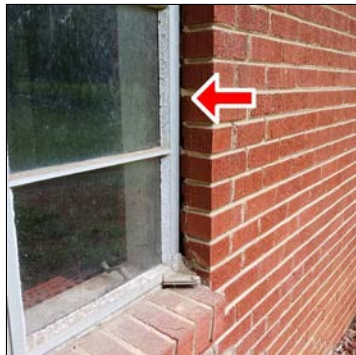
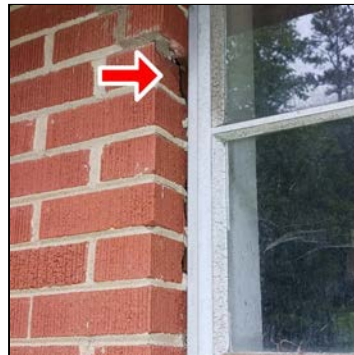
2.4 Observed multiple areas of separation at the front left breezeway window and the brick veneer. This may be caused by a settling condition or brick pulling away in this area. Condition is conducive to further damages and potential water penetrations. Evaluation / Correction by a qualified general contractor is recommended for this entire condition.

Front left window gap

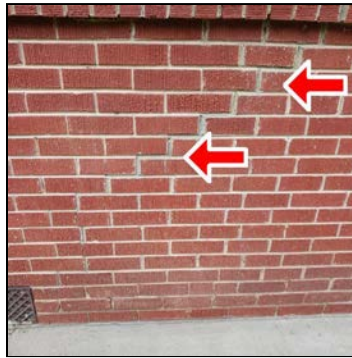
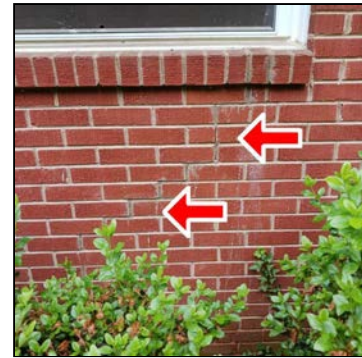
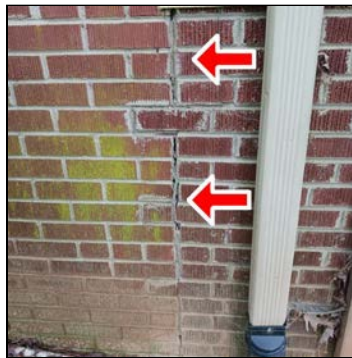
2.4 Observed a stair step crack in the brick veneer at multiple locations around the home with some displacement evident (See photos for locations). Condition is conducive to further damages. Evaluation / Correction by a qualified general / masonry contractor is recommended for this entire condition.

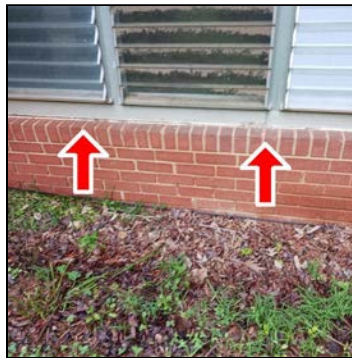
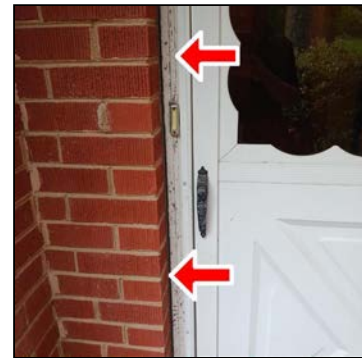
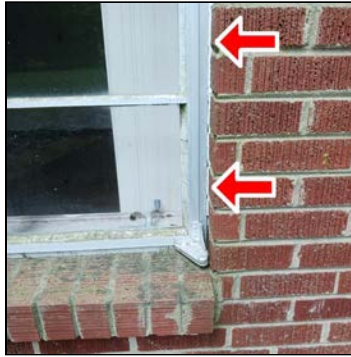
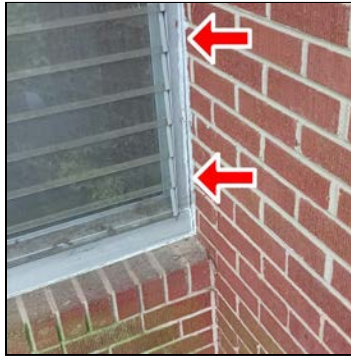
2.4 Observed multiple locations where caulk sealing is needed where the brick veneer meets the vinyl / wood / metal trim (See photos for locations). Condition is conducive to potential water penetrations and other damage. Evaluation / Correction by a qualified handyman contractor is recommended for this entire condition.

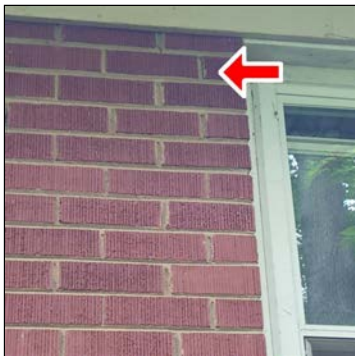
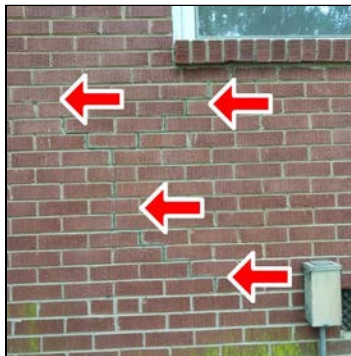
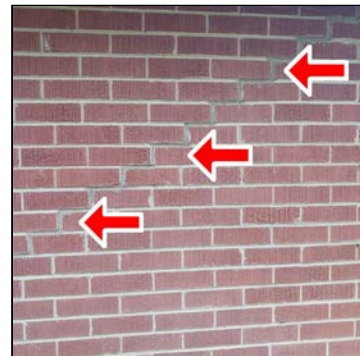
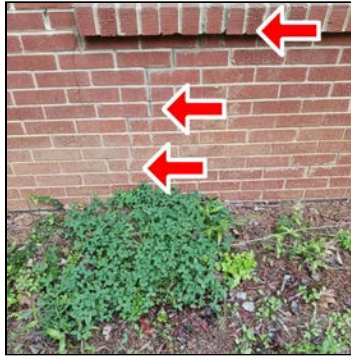
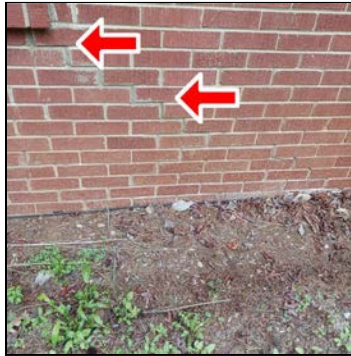
2.4 Observed small cracks in the brick veneer at several locations (See photos for locations). These are typical in nature due to age and normal masonry shrinkage. Although small cracks in brick veneers are typical, these areas should be resealed too prevent any water penetrations or damages and subsequently monitored. Evaluation / Correction by a qualified handyman contractor is recommended for this entire condition.

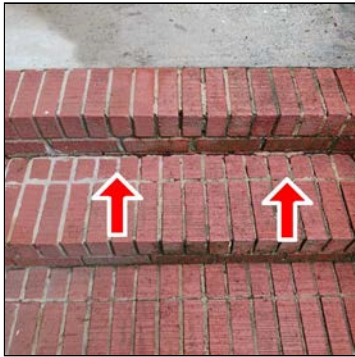
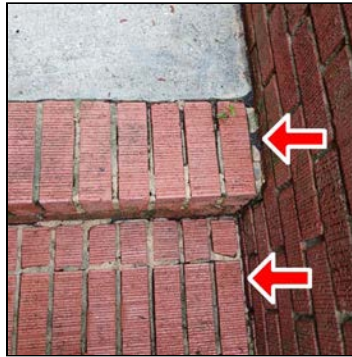
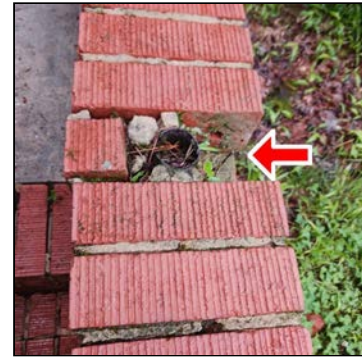
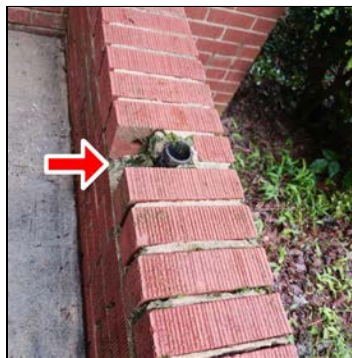
Front steps

2.9 Observed open mortar joints and loose bricks at the front steps in several locations. All open mortar joints need to be sealed to prevent water penetrations. Condition is conducive to further damages. Evaluation / Correction by a qualified handyman contractor is recommended for this entire condition.
