This home is not sweat equity fun project or a “lipstick on a pig flip.”

The home has serious issues/repairs that need a seasoned contractor with a knowledgeable team to figure out assessing and fixing to have the ability to grow equity and maximize its potential and profit.

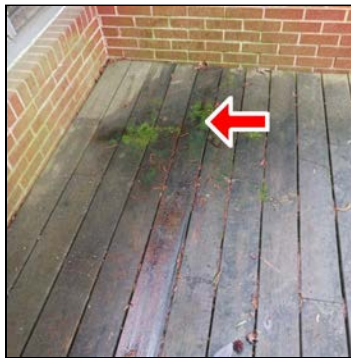
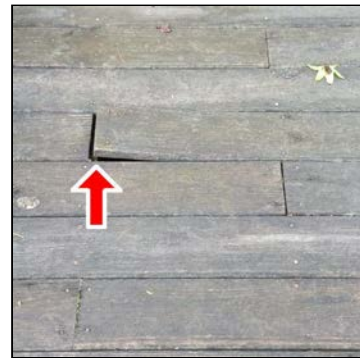
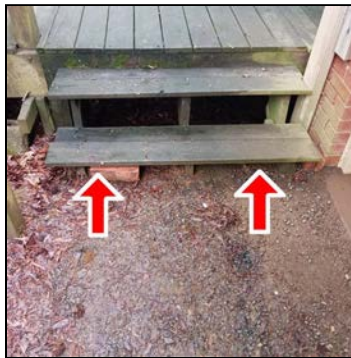
2.10 Observed decking and railings to have cracked / deteriorated materials in various areas and some nails are backing out. Repair / replace cracked and deteriorated materials as needed and for weathered deck surfaces we recommend sealing wood as needed and resetting nails. Condition is conducive to further damages. Evaluation / Correction by a qualified general / handyman contractor is recommended for this entire deck / condition.

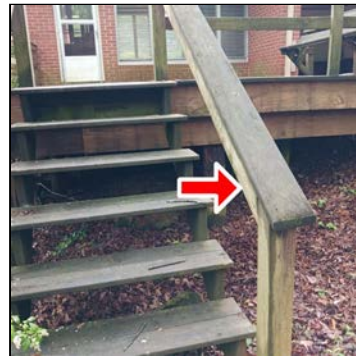
2.12 Observed loose railings at the bottom of the rear deck posts. Condition is conducive to potential safety concerns. Evaluation / Correction by a qualified handyman contractor is recommended for this entire condition.

Rear deck step railing loose

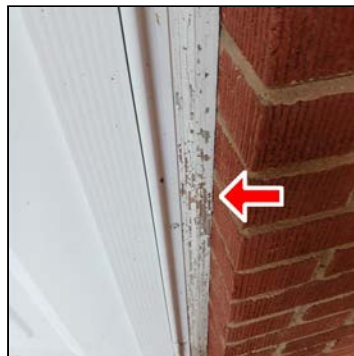
2.14 Observed chipping / cracking and the possibility of lead based paint at various areas of the exterior. Lead based paint in homes built prior to 1979 is very common. This was a standard practice at the time that the home was built. There have been many documented concerns with regards to the potential safety hazards of lead based paint when it is chipping / peeling and cracked. Client is advised to seek consultation from a qualified contractor in regards to treating these conditions.

Possible lead based paint

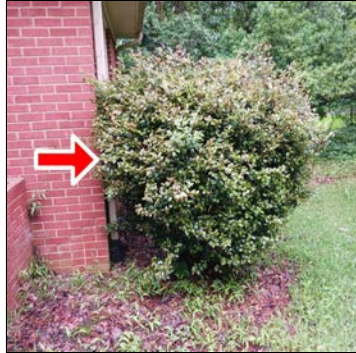
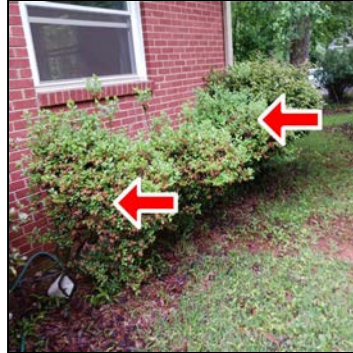
Vegetation

3.4 Observed vegetation that is in direct contact with building materials. This is a condition conducive to further damages. Cutting back at least 12 inches is recommended. Evaluation / Correction by a qualified handyman contractor is recommended for this entire condition.

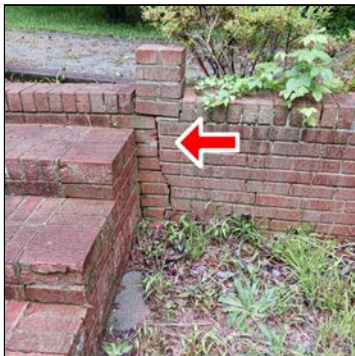
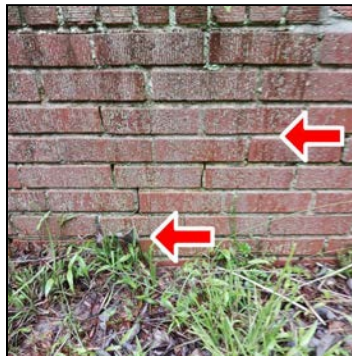
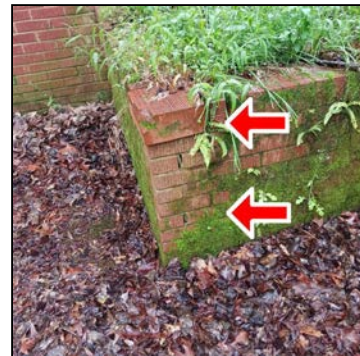
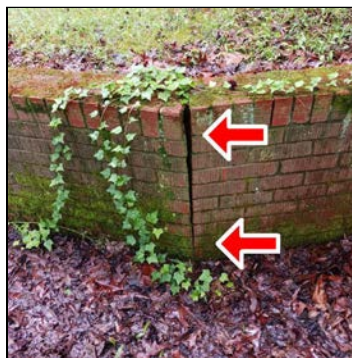
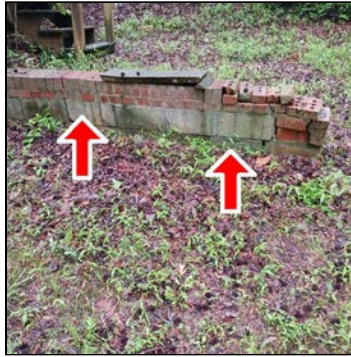
3.5 Observed multiple retaining walls that are leaning and have areas of displacement in the brick. Condition is conducive to further retaining wall failures over time. Evaluation / Correction by a qualified general contractor is recommended for this entire condition.

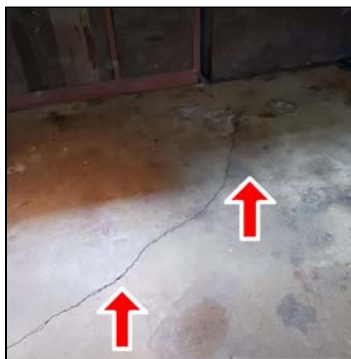
4.0 Observed sections of the garage floor that are raised up with some displacement. Although concrete movement and typical cracking is common in almost every home this condition poses a safety (tripping) hazard. Evaluation / Correction by a qualified general / concrete contractor is recommended for this entire condition.

Garage slab cracks

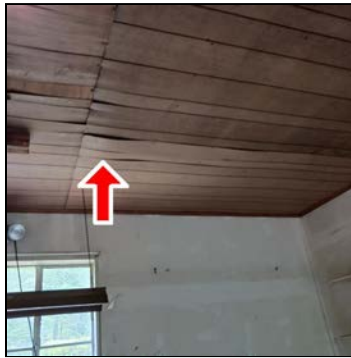
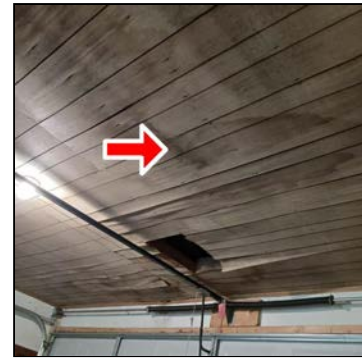
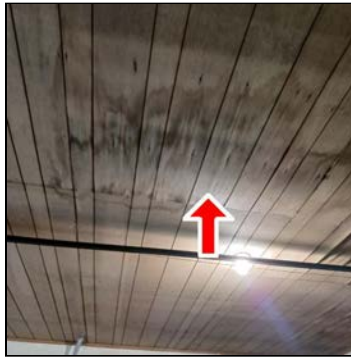
Garage ceiling

The garage ceiling is Lead paint

4.1 Observed water stains and damaged areas in the garage ceiling and walls in multiple locations. These stains are likely from previous roof leaks and damages. Evaluation / Correction by a qualified general contractor is recommended for this entire condition.

*Lead based paint would require a certified hazmat crew to scrape paint off. Could be a starting price of \$9000 to fix the garage.

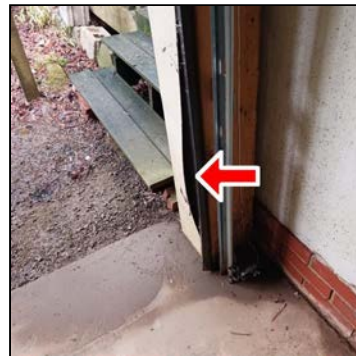
4.4 Observed an area of loose trim around the exterior of the garage door. Evaluation / Correction by a qualified handyman contractor is recommended for this entire condition.

Loose trim around garage door

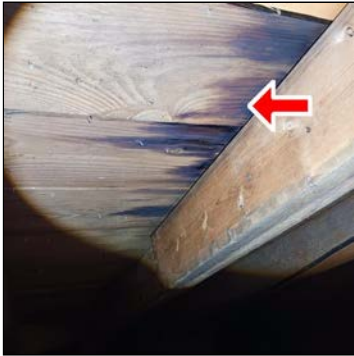
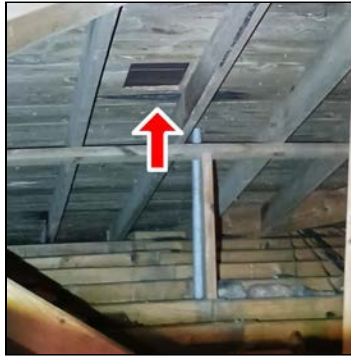
Front

5.1 Observed water stained and damaged roof sheathing at the front and rear attic that needs to be repaired / replaced (See photos). Condition is conducive to further damages / roof leaks. Evaluation / Correction by a qualified general / roofing contractor is recommended for this entire condition.

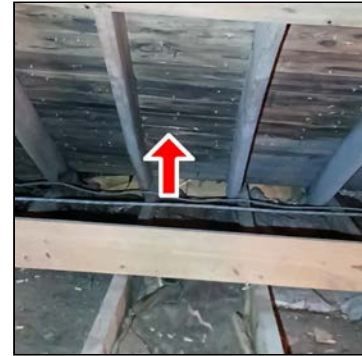
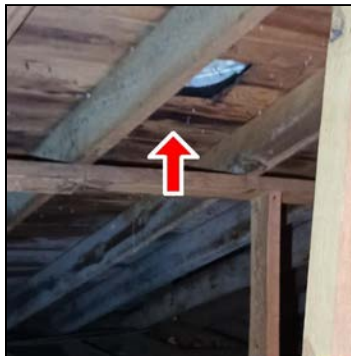
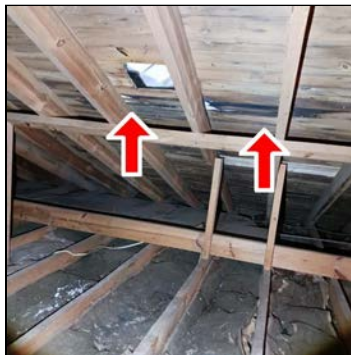
Rear

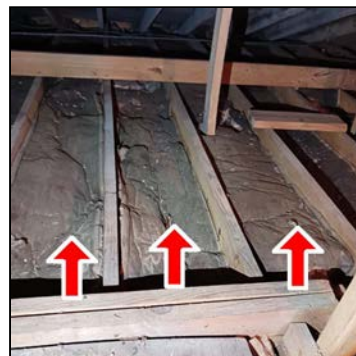
5.3 Observed attic insulation that is moved / compressed in various areas throughout. Condition is conducive to Heat / AC loss. Evaluation / Correction by a qualified handyman contractor is recommended for this entire condition.

Compressed insulation in attic

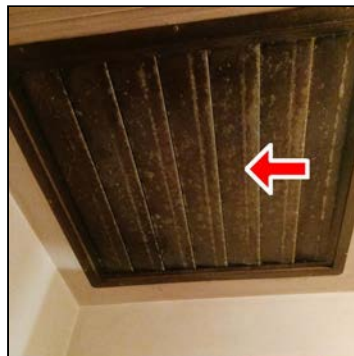
5.5 Observed that the attic vent fan did turn on during testing but the vent fan flaps did not open as intended. Evaluation / Correction by a qualified electrical contractor is recommended for this entire condition.

Vent fan flaps

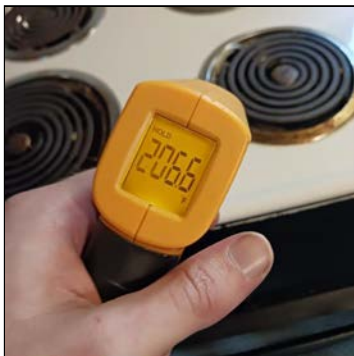
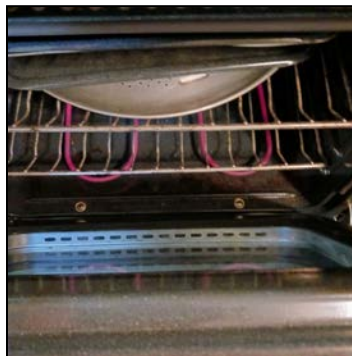
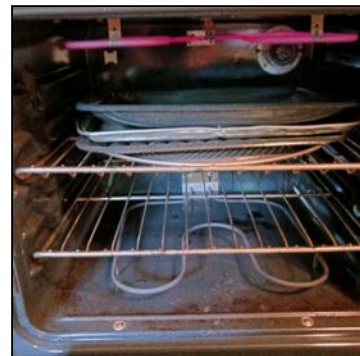
6.3 Per the FSHI Report Guarantee Program this item is rated fair due to age but functions as intended.

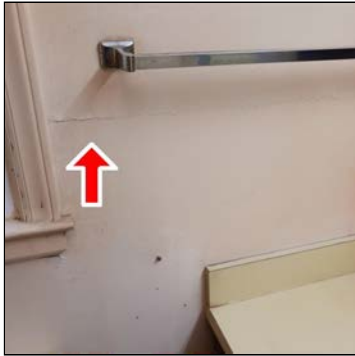
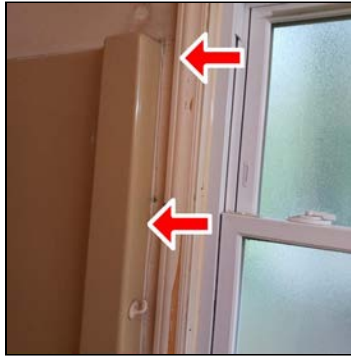
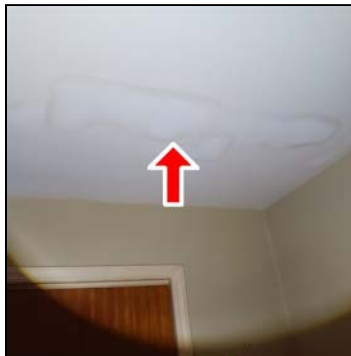
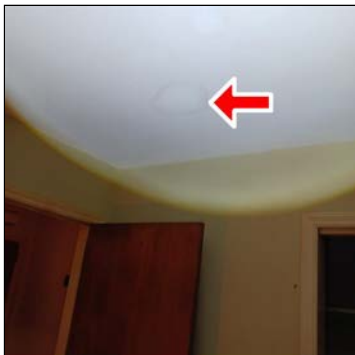
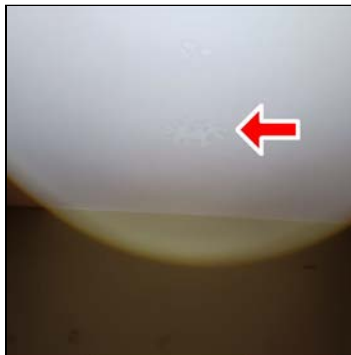
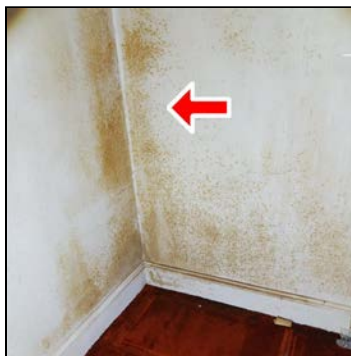
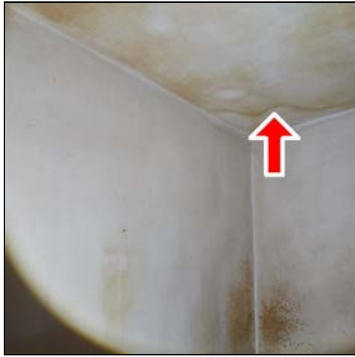
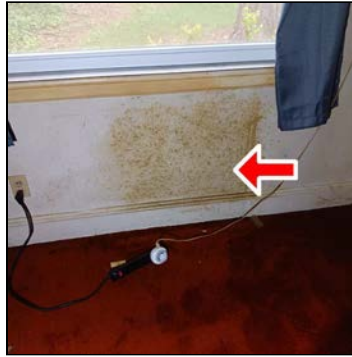
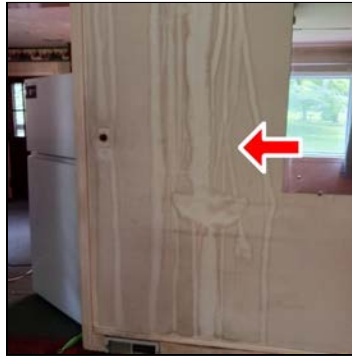
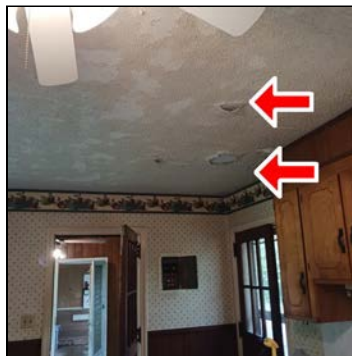
7.0 Observed extensive drywall cracks, water stains, damaged ceilings and smoke damages throughout the home. Condition is conducive to further damages. Evaluation / Correction by a qualified general contractor is recommended for this entire condition.

Damages throughout

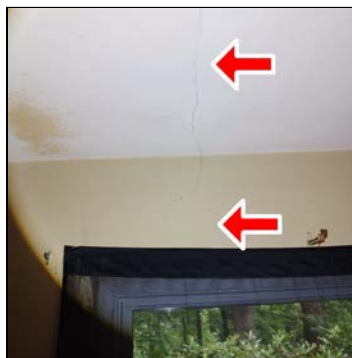
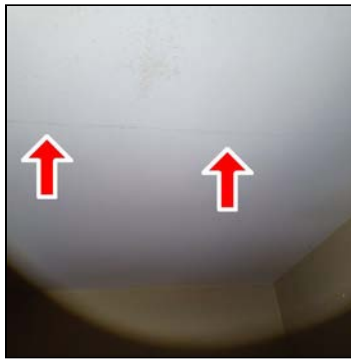
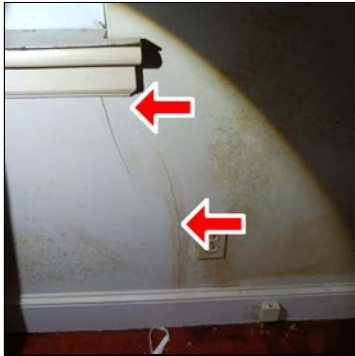
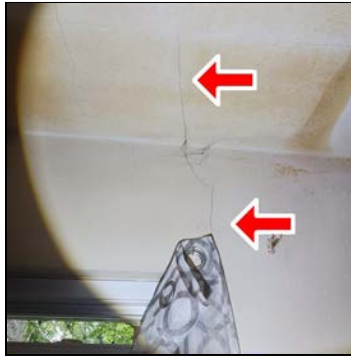
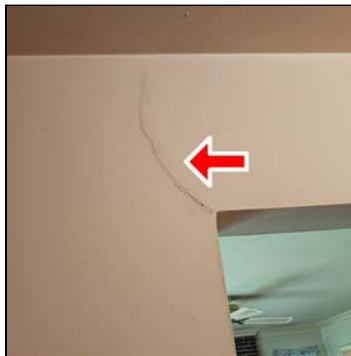
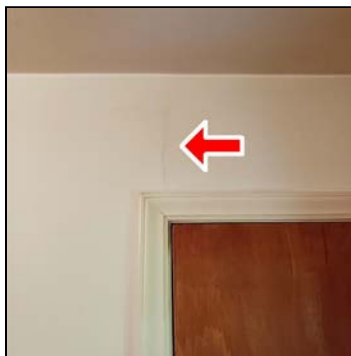
7.0 Observed multiple drywall cracks with some displacement throughout the home. Some of these cracks appear to be structural in nature and need further review. Evaluation / Correction by a qualified general contractor / structural engineer is recommended for this entire condition.

Displaced drywall cracks throughout

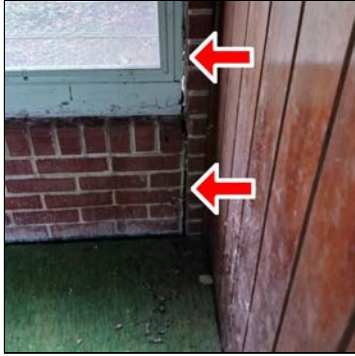
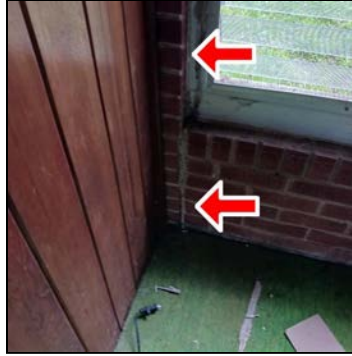
7.1 Observed gaps in the brickwork with visible daylight in the walkway between the garage and the

house. Condition is conducive to further damages / water penetrations. Evaluation / Correction by a qualified general contractor is recommended for this entire condition.

Visible daylight in garage walkway walls

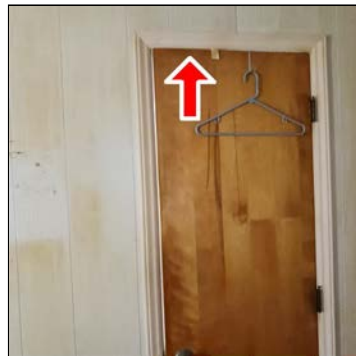
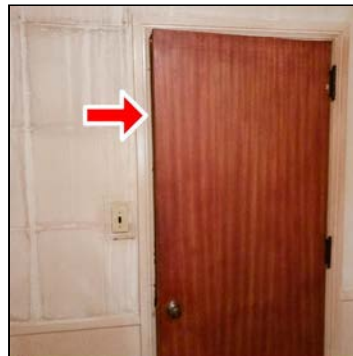
7.6 Observed that several of the room and closet doors hit and rub the door frames, see photos for locations. This is typically due to expansion and contraction from seasonal interior humidity. (Recommend checking all in all locations) Evaluation / Correction by a qualified handyman contractor is recommended for this entire condition.

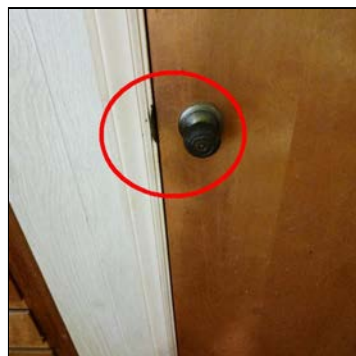
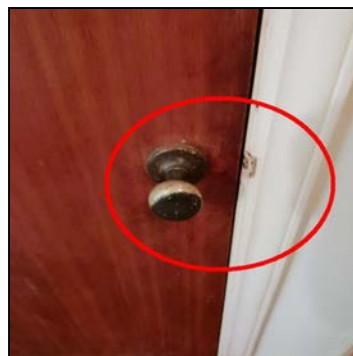
7.6 Observed that several of the room and closet doors have malfunctioning hardware that will not latch correctly, see photos for locations. This is typically due to expansion and contraction from seasonal interior humidity. (Recommend checking all in all locations) Evaluation / Correction by a qualified handyman contractor is recommended for this entire condition.

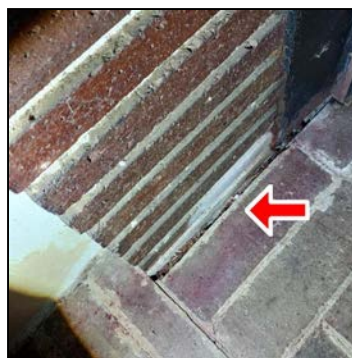
7.9 Observed a large gap between the fireplace hearth and the chimney. This may be an indication that the chimney has moved and separated itself from the home. Condition is conducive to further damages. Evaluation / Correction by a qualified general contractor is recommended for this entire condition.

Large gaps at base of fireplace

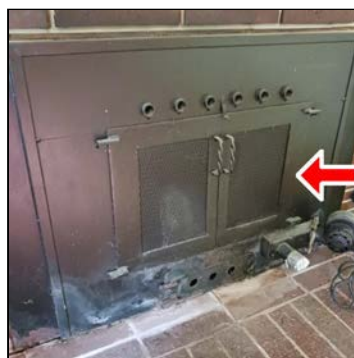
7.9 Observed a heavy soot on the throat of the fireplace chimney. Due to a height restrictions / chimney caps and other finished materials the inside of the chimney flue was not readily accessible for inspection. I/We recommend all fireplace components be cleaned and further evaluated before next use. Conditions are conducive to further damages and potential safety concerns. Evaluation / Correction by a qualified fireplace contractor is recommended for this entire condition.

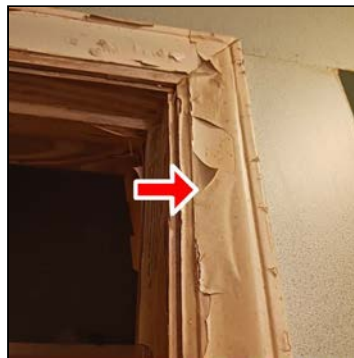
7.11 There is a likely probability that there is lead based paint throughout the interior of the home. This was a standard practice at the time that the home was built. Lead based paint in homes built prior to 1979 is very common. There have been many documented concerns with regards to the potential safety hazards of lead based paint when it is chipping / peeling and cracked. Client is advised to seek consultation from a qualified contractor in regards to treating these conditions.

Possible lead based paint

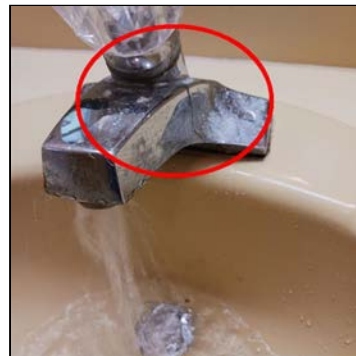
8.0.A Observed that the master bathroom sink leaks at the faucet handle. Condition is conducive to further damages. Evaluation / Correction by a qualified plumbing contractor is recommended for this entire condition.

Leaks

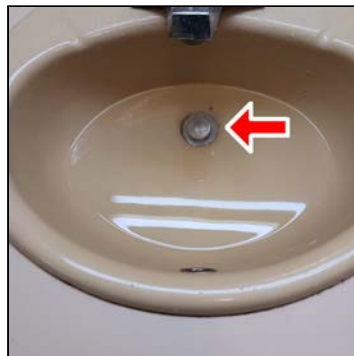
8.0.A Observed that the master bathroom sink is slow to drain. This is likely caused by a clog. Evaluation / Correction by a qualified plumbing contractor is recommended for this entire condition.

Master sink slow drain

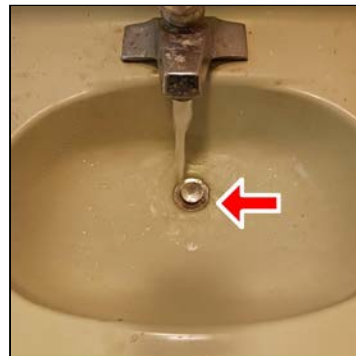
8.0.B Observed that the master bath drain stopper did not function properly / did not hold water. Evaluation / Correction by a qualified plumbing contractor is recommended for this entire condition.

Hall bath sink stopper

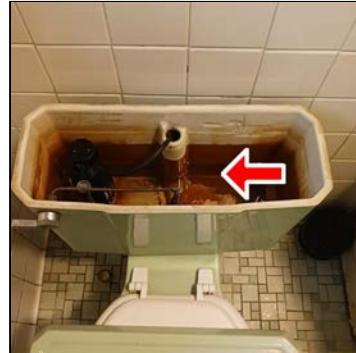
8.1.B Observed that the hall bathroom toilet did not refill after being flushed. It may be that the water is turned off to the toilet or other issues. Evaluation / Correction by a qualified plumbing contractor is recommended for this entire condition.

Hall bath toilet

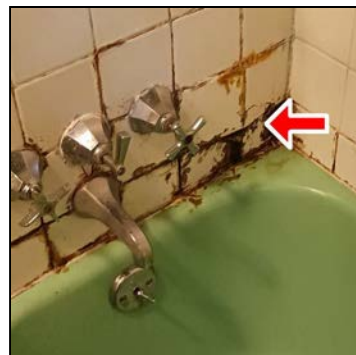
8.3.B Observed severely damaged tile work around the hall bathroom tub walls. This may be from past or current plumbing leaks and a lack of maintenance. Evaluation / Correction by a qualified general contractor is recommended for this entire condition.

Hall bathtub tile walls

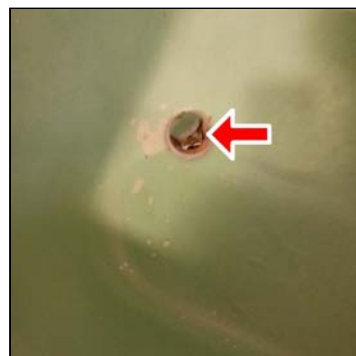
8.3.B Observed chips and damages in the hall bathroom tub base. Condition is conducive to further damages. Evaluation / Correction by a qualified general contractor is recommended for this entire condition.

Tub base

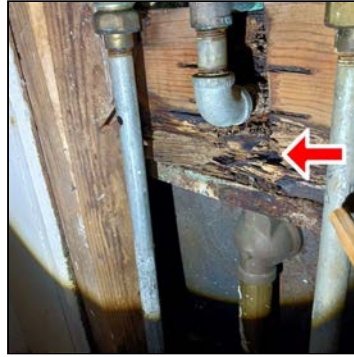
Behind hall bathroom tub

8.3.B Observed areas of rot / decay behind the hall bathroom tub from a past or current leak. Evaluation / Correction by a qualified general / plumbing contractor is recommended for this entire condition.

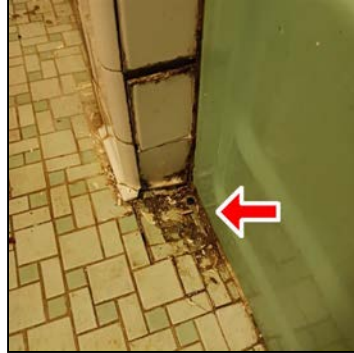
Damaged floor hall bathroom

8.6.B Observed damaged / Collapsed flooring on the exterior of the hall bathroom tub. Condition is conducive to further damages. Evaluation / Correction by a qualified general contractor is recommended for this entire condition.

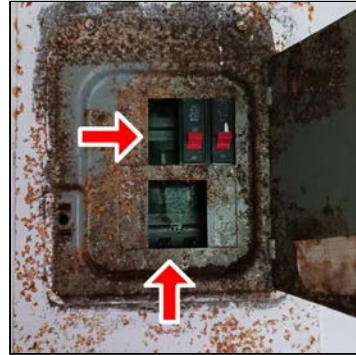
Basement panel

9.4 Observed several knockouts that were removed at the basement sub panel. All holes in the side or the front cover of the panel needs to be plugged / covered. Condition is conducive to potential safety concerns. Evaluation / Correction by a qualified electrical contractor is recommended for this entire condition.

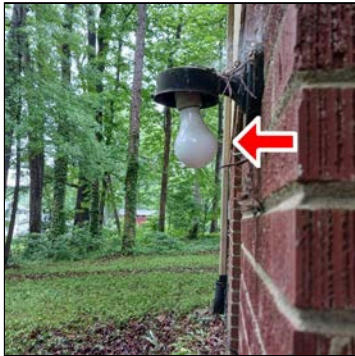
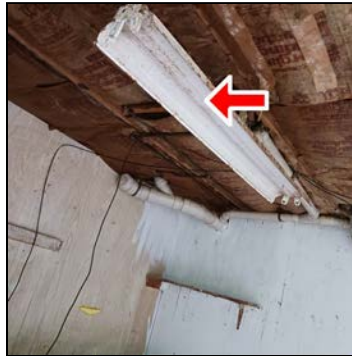
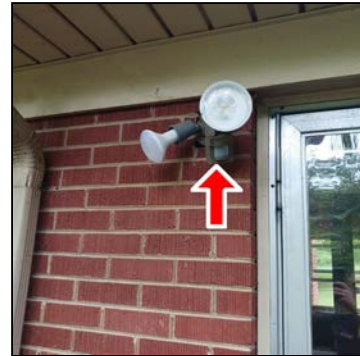
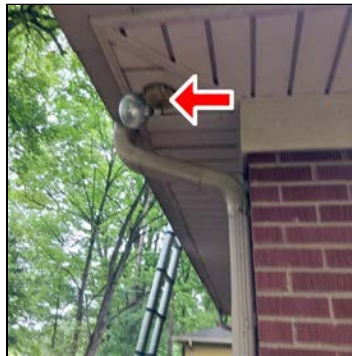
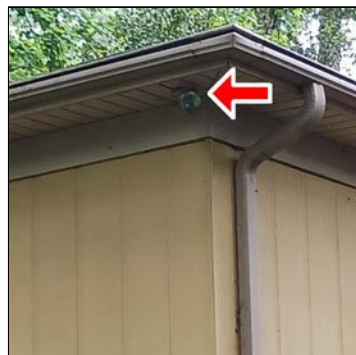
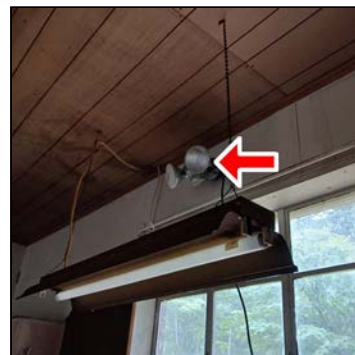
9.5 Observed that several lights in various locations did not function (See photos for locations). Recommend bulb replacement to ensure proper function first. If not bulb then Evaluation / Correction by a qualified electrical contractor may be necessary.

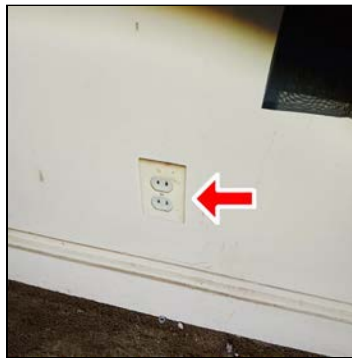
9.6 Observed electrical outlets in multiple areas that tested to have an either no / open or broken ground throughout the home. Condition is conducive to potential safety hazards. Evaluation / Correction by a qualified electrical contractor is recommended for this entire condition.

Ungrounded outlets throughout

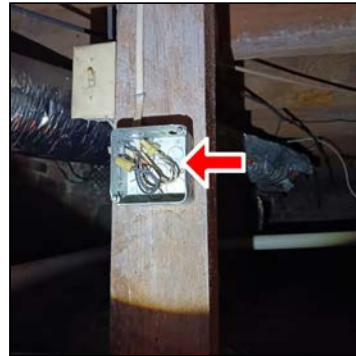
9.6 Observed improperly terminated wiring in the crawl space. These wires need to be properly installed inside a junction box and covered. Condition is conducive to a potential safety hazard. Evaluation / Correction by a qualified electrical contractor is recommended for this entire condition.

Missing junction box cover in crawl

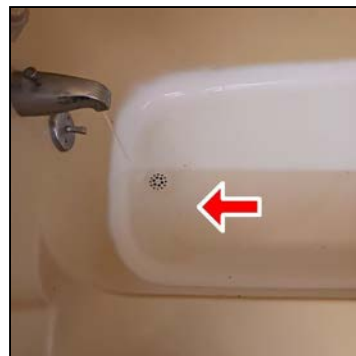
10.1 Observed discolored / stained water coming out of the tub and sink faucets. It is likely that the water heater has sediment or rust deposits in it. Condition is conducive to other potential damages. Evaluation / Correction by a qualified plumbing contractor is recommended for this entire condition.

Discolored water

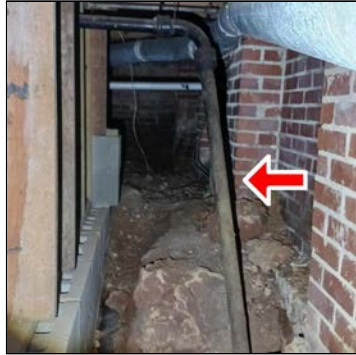
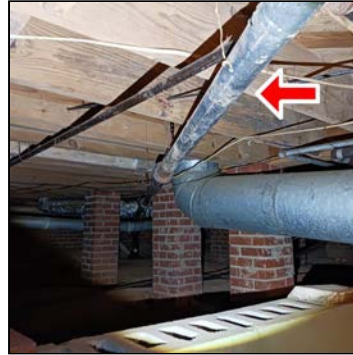
10.3 Observed that portions of the plumbing drain system are cast iron piping. Although no visible leaks were found at the time of inspection, cast iron piping can corrode in areas that are not visible. Also the rubber band boots that are used for connections are prone to leaking. Evaluation / Correction by a qualified plumbing contractor is recommended for this entire condition.

Cast iron pipes

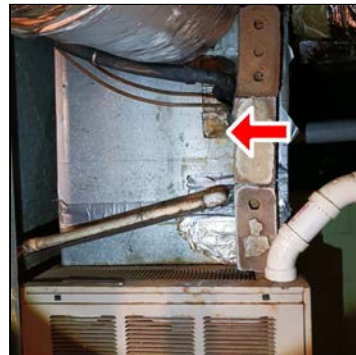
11.4 Per the standards of practice all NC / SC home inspectors are only required / allowed to remove readily accessible panels for inspection. In regards to the indoor coil units some of these panels cannot be removed due to design / obstructions / seal tape and or mastic compound. These indoor coil units work in tandem with the condenser unit outside to produce the air conditioning. Although temperature readings indicate that the unit was functioning properly at the time of inspection, it is recommended that a qualified HVAC contractor further evaluate due to no service information revealed / given to FSHI at the time of inspection.

Indoor coil not inspected

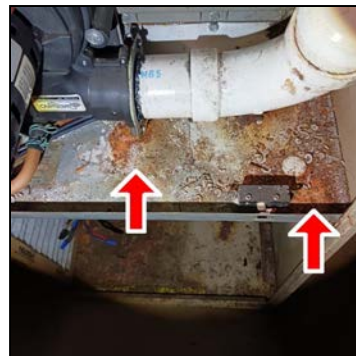
Rust

12.1 Observed areas of rust inside the furnace burner cabinet. This is likely from age and lack of maintenance. Condition is conducive to further damages. Evaluation / Correction by a qualified HVAC contractor is recommended for this entire condition.

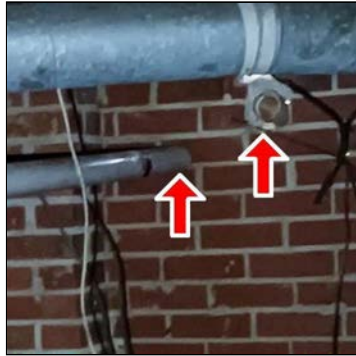
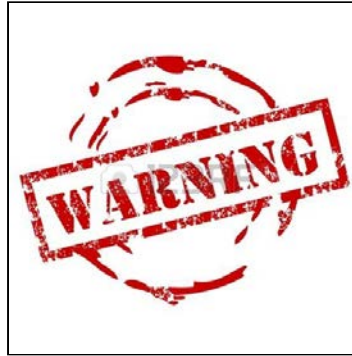
12.4 Observed that the furnace flue / exhaust pipe has come disconnected inside the crawl space. This means that the exhaust and carbon monoxide fumes are not exiting the crawl space to the exterior. **THIS IS A SAFETY HAZARD.** Evaluation / Correction by a qualified HVAC contractor is recommended for this entire condition.

Furnace flue vent disconnected in crawl

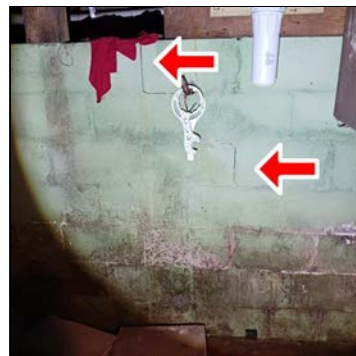
14.1 Observed a crack in the basement foundation wall at the right side with some displacement (significant movement) visible. It is likely that this condition has existed for an extended period of time. These areas should be sealed too prevent any water penetrations or further damages. Evaluation / Correction by a qualified general contractor is recommended for this entire condition.

Basement wall crack

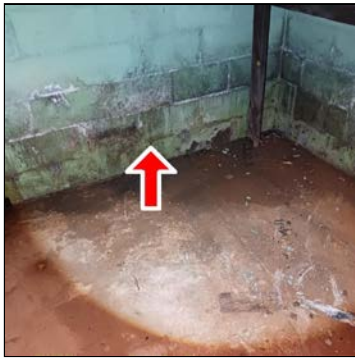
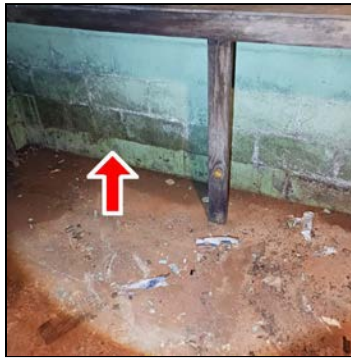
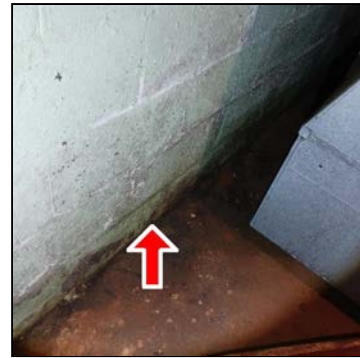
Basement walls near furnace / water heater

14.1 Observed water stains and wet areas at the bottom of the basement / crawlspace walls. This is evidence of water penetrations in this area which can lead to high moisture levels and other issues. Evaluation / Correction by a qualified general contractor is recommended for this entire condition.

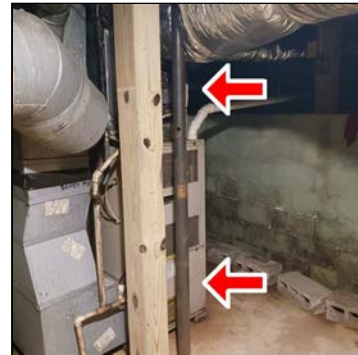
14.5 Observed a commercial grade metal jack stud that has been used as a pier in lieu of the typical masonry block pier. These jack studs are being used to support all of the drop girder beams in the crawlspace section of the house. Metal jack studs are acceptable in some applications but they must be installed exactly according to the manufacturers installation instructions. Evaluation / Correction by a qualified contractor / structural engineer is recommended for this entire condition.

Metal jack stud

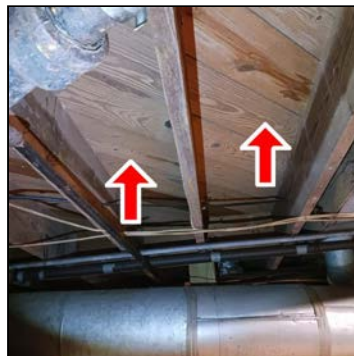
14.7 Although not a requirement at the time the home was built the client may consider adding insulation in the floor system for added efficiency to reduce heating and cooling capacities.

No insulation

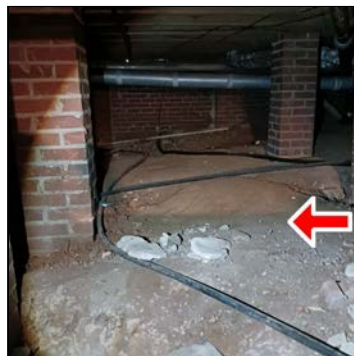
14.8 Observed no moisture barrier in the crawl space. Moisture barriers keep under ground moisture from entering the crawl space area. Condition is conducive to high moisture content, which in turn is conducive to wood destroying insects / fungi growth and other potential concerns. It is highly recommend that a 6 mil ploy plastic be installed and covering 100% of the dirt area. Evaluation / Correction by a qualified contractor is recommended for this entire condition.

No moisture barrier

\$5327 Crawl Space Mold repair/vapor barrier/drylock foundation

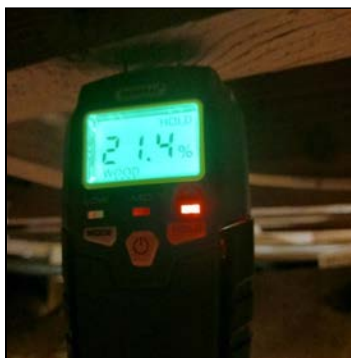
14.9 Observed a high moisture condition all throughout the crawl space. This condition is conducive to wood rot / decay, wood destroying insects and also mildew / fungus growth. Moisture readings in the substructure were at unacceptable levels from 20% to 25% at the time of inspection and evidence shows that the condition worsens during the warmer months of the year. Evidence of active and inactive fungi conditions was observed through out most of the crawlspace area. There was also evidence of water penetrations and wet soil in the crawl space / basement. Evaluation / Correction by a qualified fungi remediation and general contractor is recommended for this entire condition.

High moisture levels

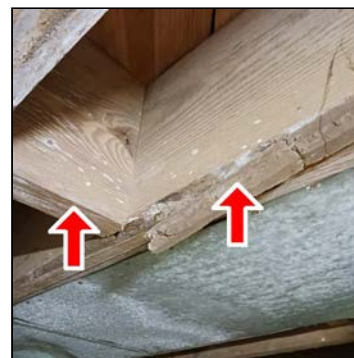
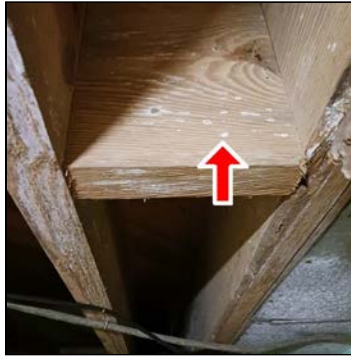
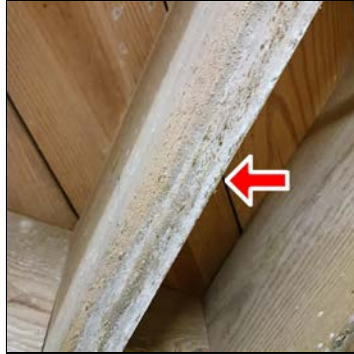
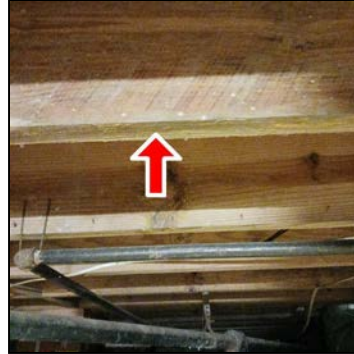
Fungi

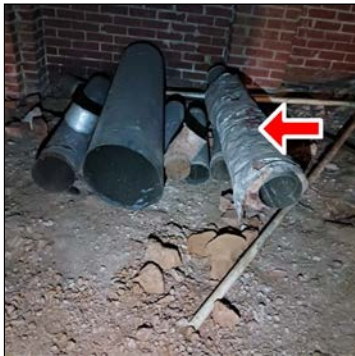
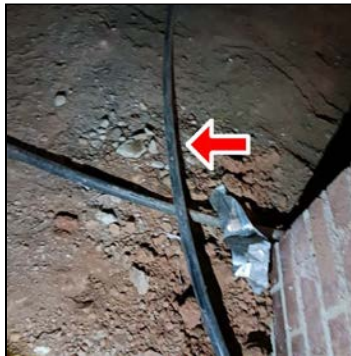
14.10 Observed wood debris and other trash items in the crawl space. All wood, trash or cardboard debris must be kept out of crawl space areas. Condition is conducive to wood destroying insects and other potential concerns. Evaluation / Correction by a qualified handyman contractor is recommended for this entire condition.

Trash in crawl space
